Evergreen Meadows – Plan Unit 2

Rating: Moderate

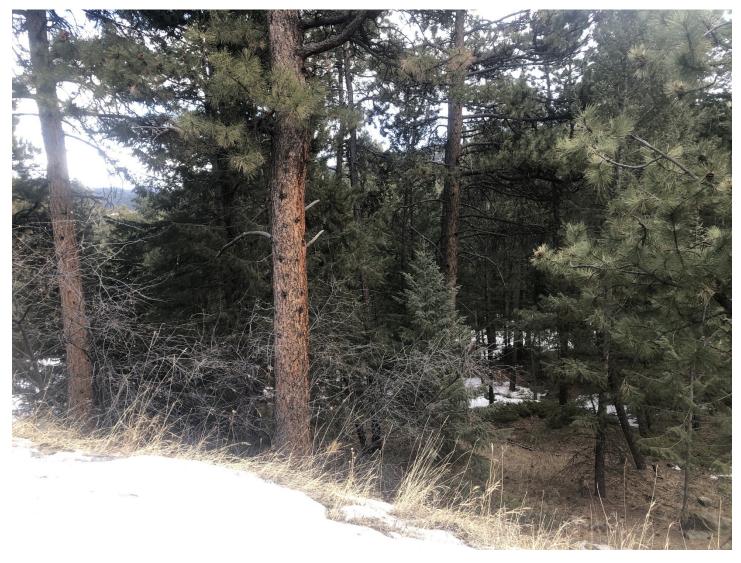
Many homes on ridges have evidence of thorough treatments but some portions of properties have been left untouched, such as some property visible from S Centaur Drive.

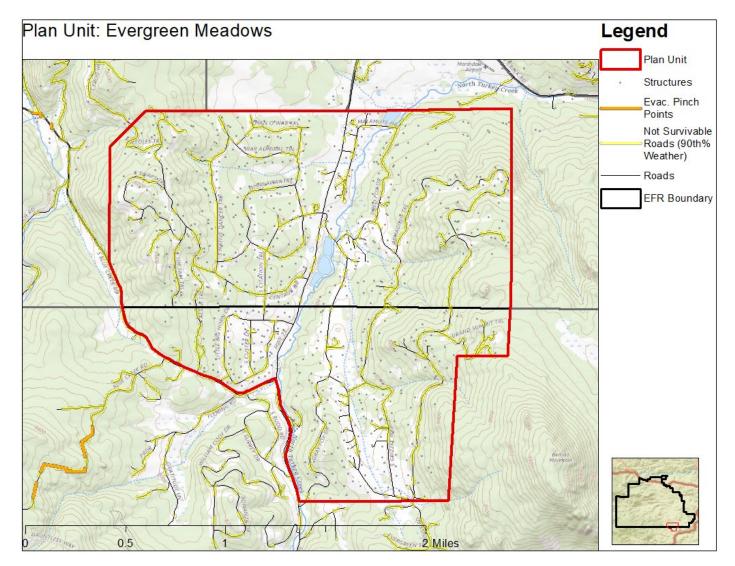
Evergreen Meadows has no modeled Evacuation Pinch Points. CO Road 73 is a major evacuation corridor for Evergreen Meadows and is in great shape. On this road between Gray Fox Rd. and S. Centaur Dr. there is some vegetation along the roadway that could be mitigated to further improve this location. The next recommended priority areas are next evacuation roadways that are non-survivable. This should include S. Centaur Dr., Fleming Rd., Citation Trail, Native Dancer Trail, and S. Grizzly Way. Residents should work together in this Plan Unit to improve roadways and focus first on roads closest to CO Road 73.

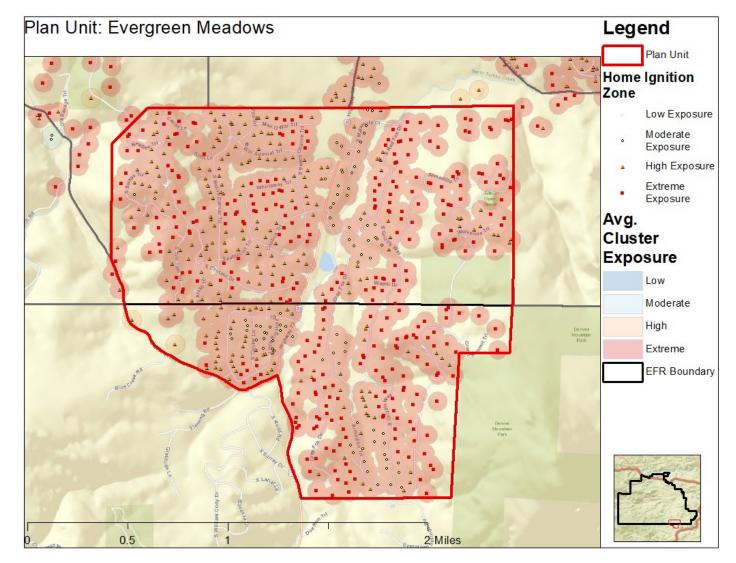
Evergreen Meadows has many high and extreme exposure structures, and the average cluster exposure is extreme. This extreme cluster exposure means homes that are at lower risk from radiant heat & short- and long-range spotting are put at higher risk by their connection to other, higher risk structures. Developing robust defensible space work and implementing home hardening practices will reduce the rating of this cluster. Edges of Evergreen Meadows, on the East and West sides, are most vulnerable to radiant heat.

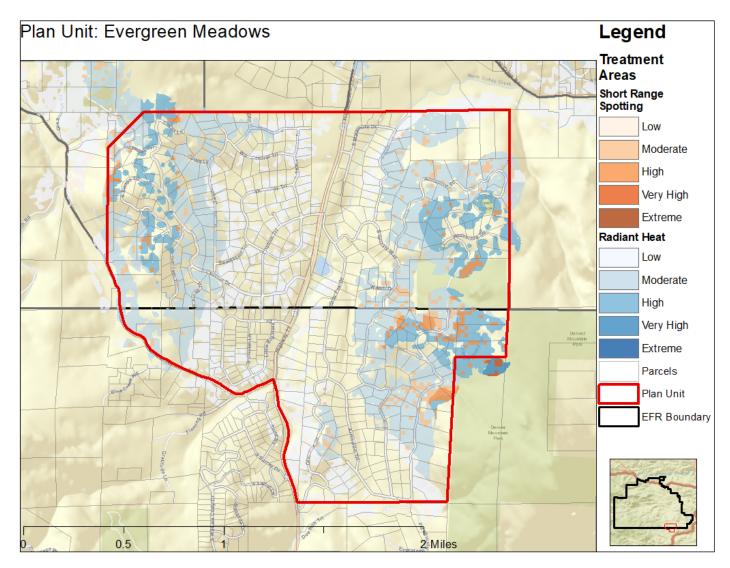
Eastern and western sides of Evergreen Meadows are in highest need of fuel treatment, defensible space, and home hardening improvements. This community should work together to implement this mitigation work, as the cluster exposure indicates all residents are at risk from these extreme exposure areas.
