STAGECOACH/HIWAN HILLS – PLAN UNIT 14

Rating: High

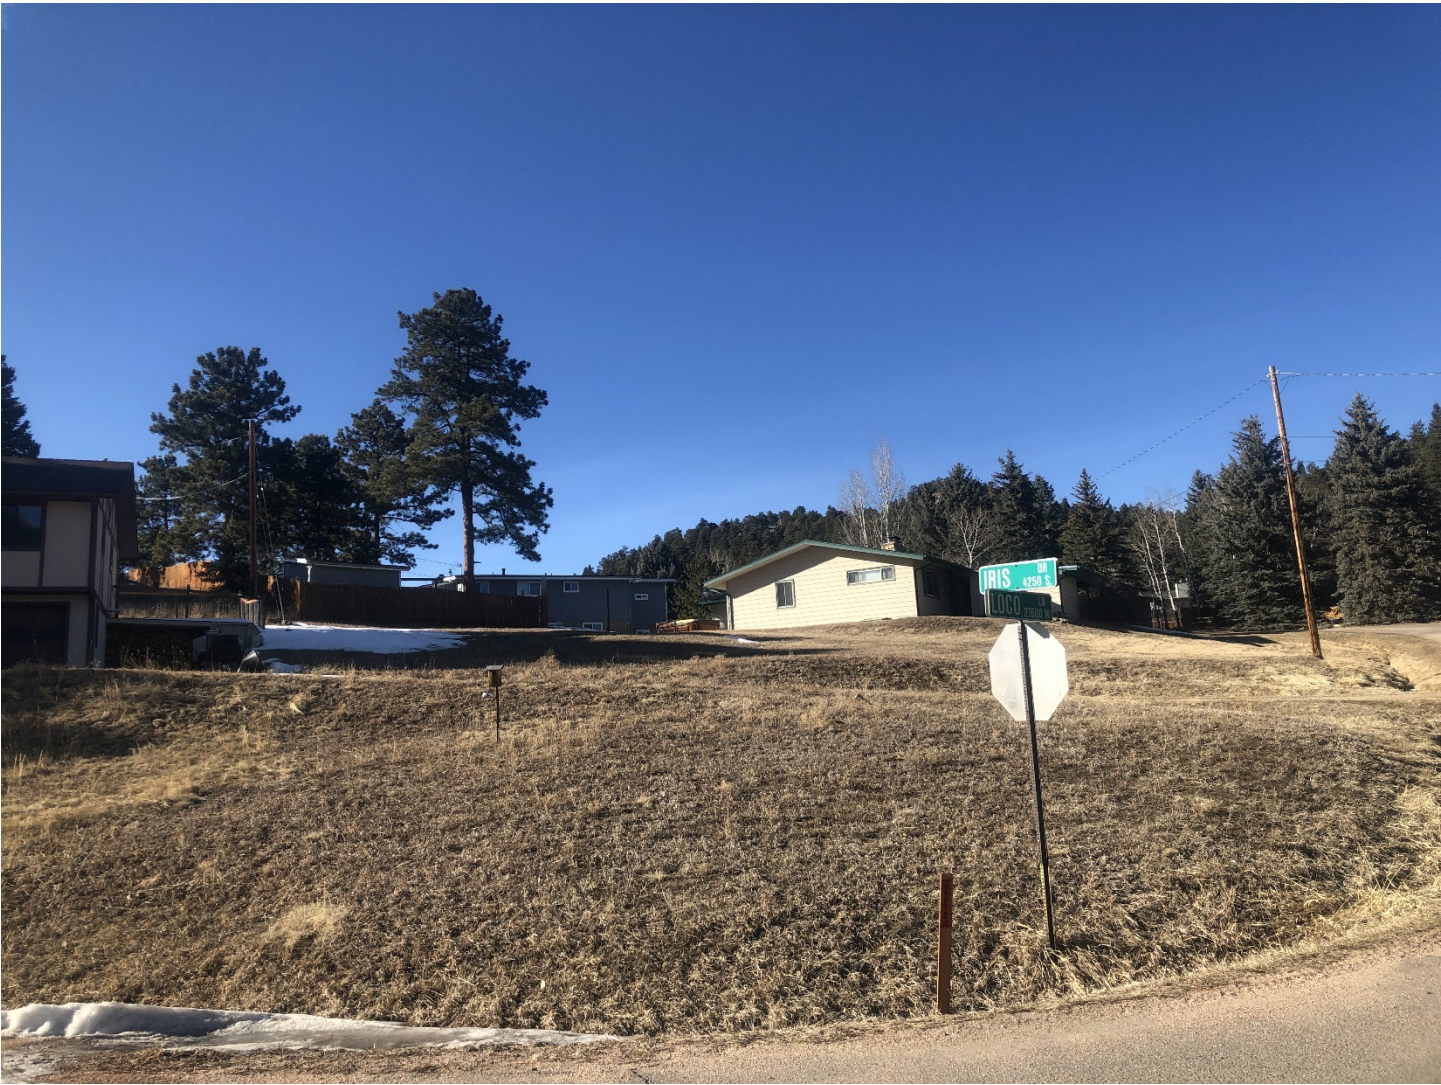
Areas within this Plan Unit boundary could be separated into two different conditions. Grass dominated areas around El Pinal and Chestnut Drive, between Paint Brush and Ponderosa Drive, and area around Fireweed to Iris Drive share the following characteristics: lack of timber or timber litter to sustain fire spread, and short stature grass fuels limiting fire spread. Fire risk in these areas is lower than other areas within the Plan Unit. Some areas exhibit defensible space while others are situated within moderate timber/litter fuel with no evident wildfire mitigation. It is evident that some landowners have not improved the Home Ignition Zone. It is recommended that these property owners mitigate to match neighboring property. Road access is excellent, and hydrants are present throughout. There are commercial businesses within the unit along the bottom edge adjacent to Evergreen Parkway.

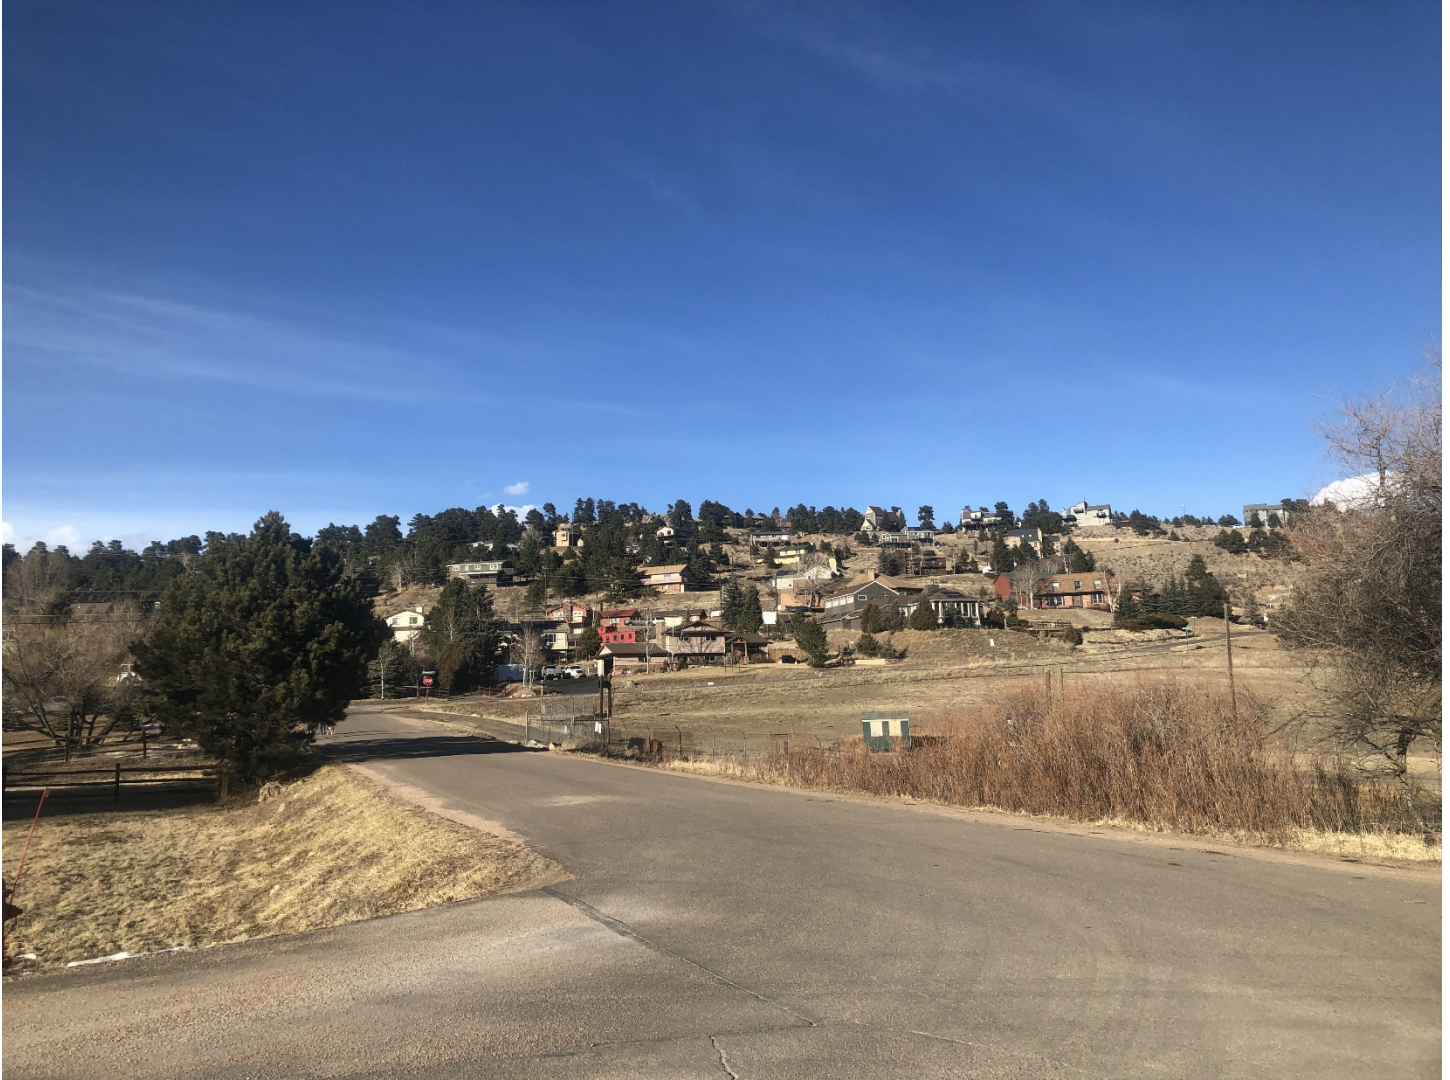
Homes are older but maintained well. Short grass or mowed areas will improve tactical fire response and limit catastrophic ember wash during a wildfire.

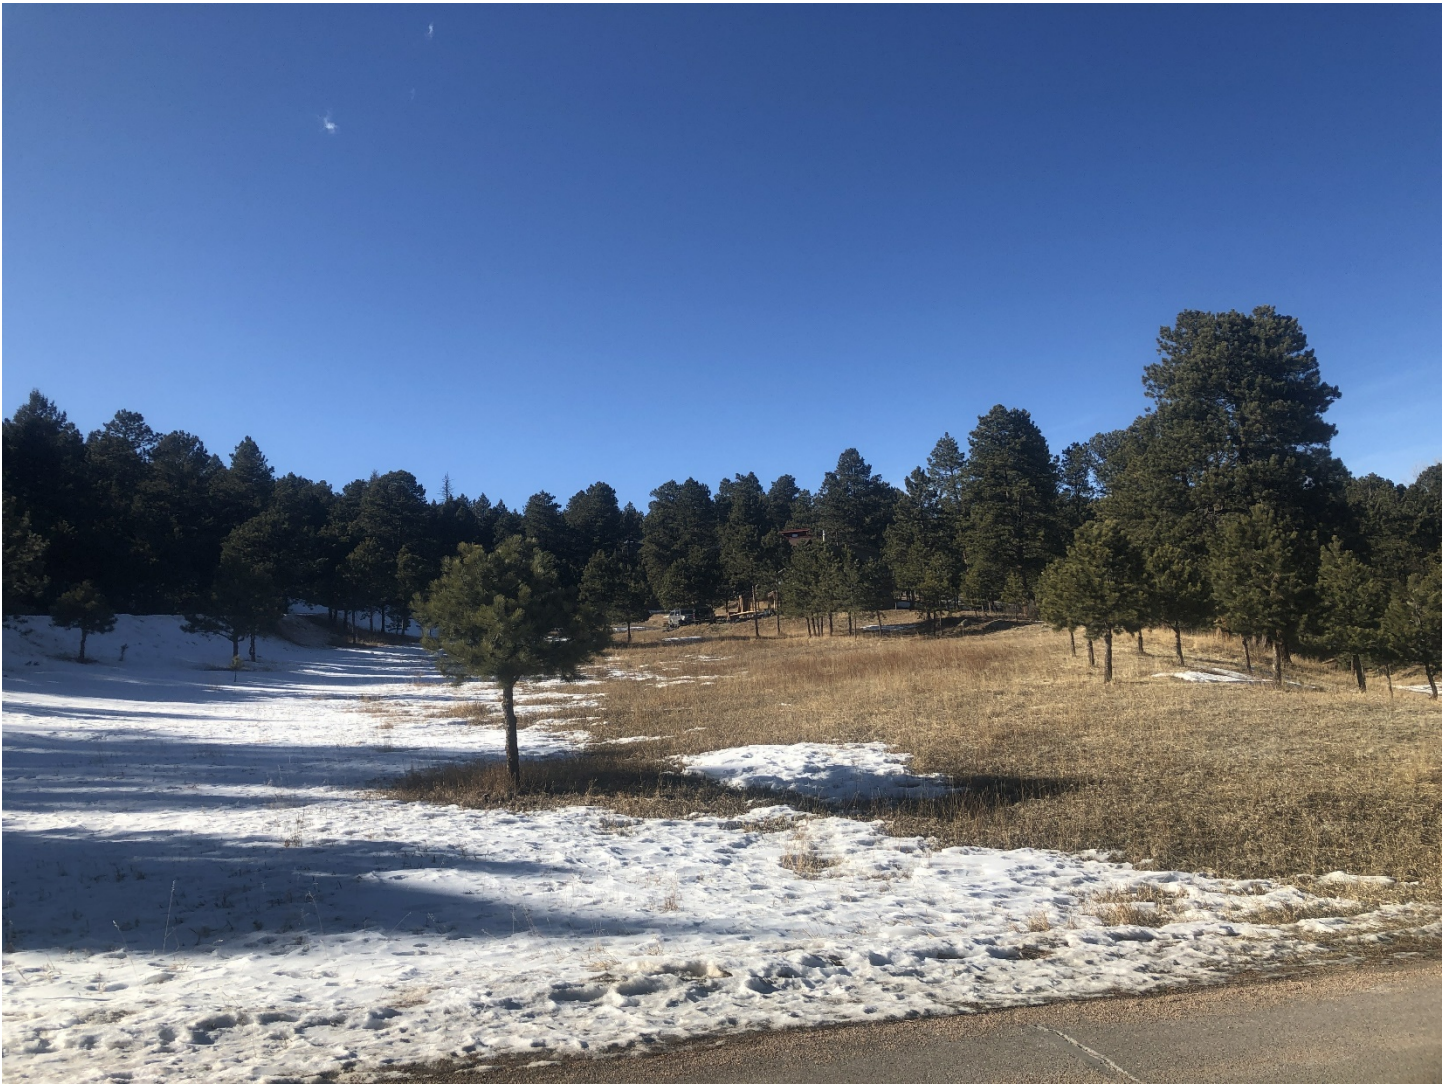
El Pinal area has low timber fuel loading and many locations that would serve as shelter-in-place with some improvement. Surface fuels are continuous which will increase rates of spread. Home hardening is very important in this neighborhood as fire spread will be quick, but not as sustained as other parts of this unit.

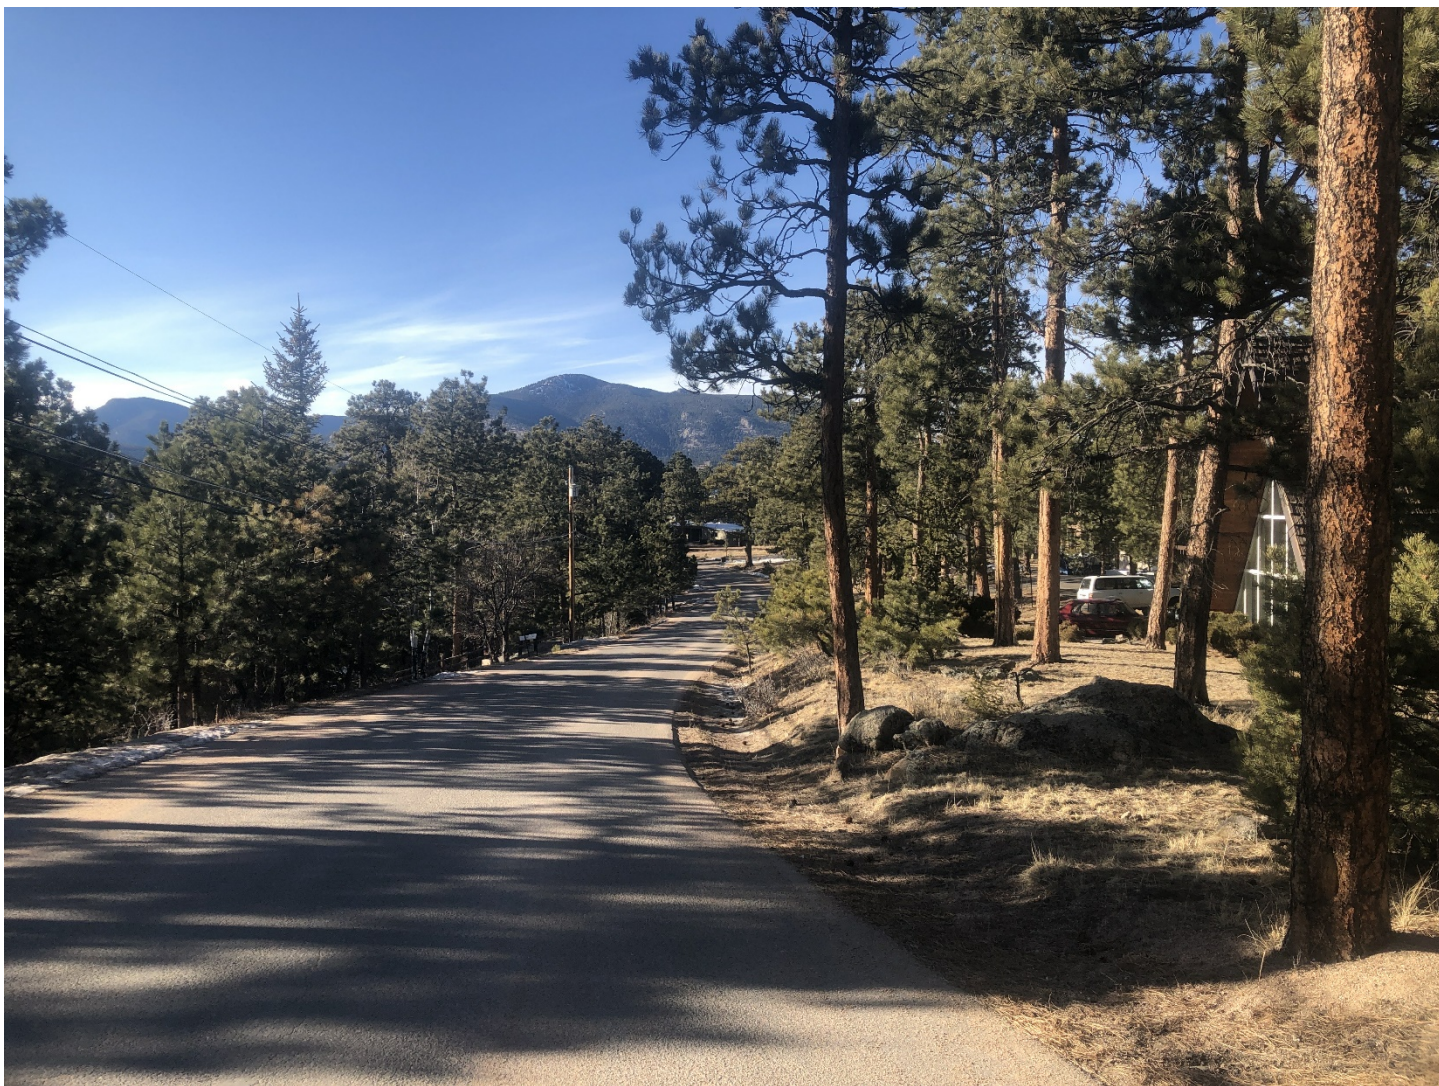
Most of this Plan Unit has gentle, rolling topography and lower density Ponderosa Pine. Dense pockets of timber in the unit, like along Hidden Village Drive should be thinned to mimic other defensible areas. Roadways are paved and wide with large driveways providing access to large engines. Housing stock is newer with more fire-resistant materials in the area around Histed Drive and Western Drive.

In the timbered areas, fuel loading reflects aspect and owner management. Crown spacing should be 15-feet, at minimum, and roadway clearing should be prioritized. A little work will go a long way in this Plan Unit as much of the area is well mitigated.

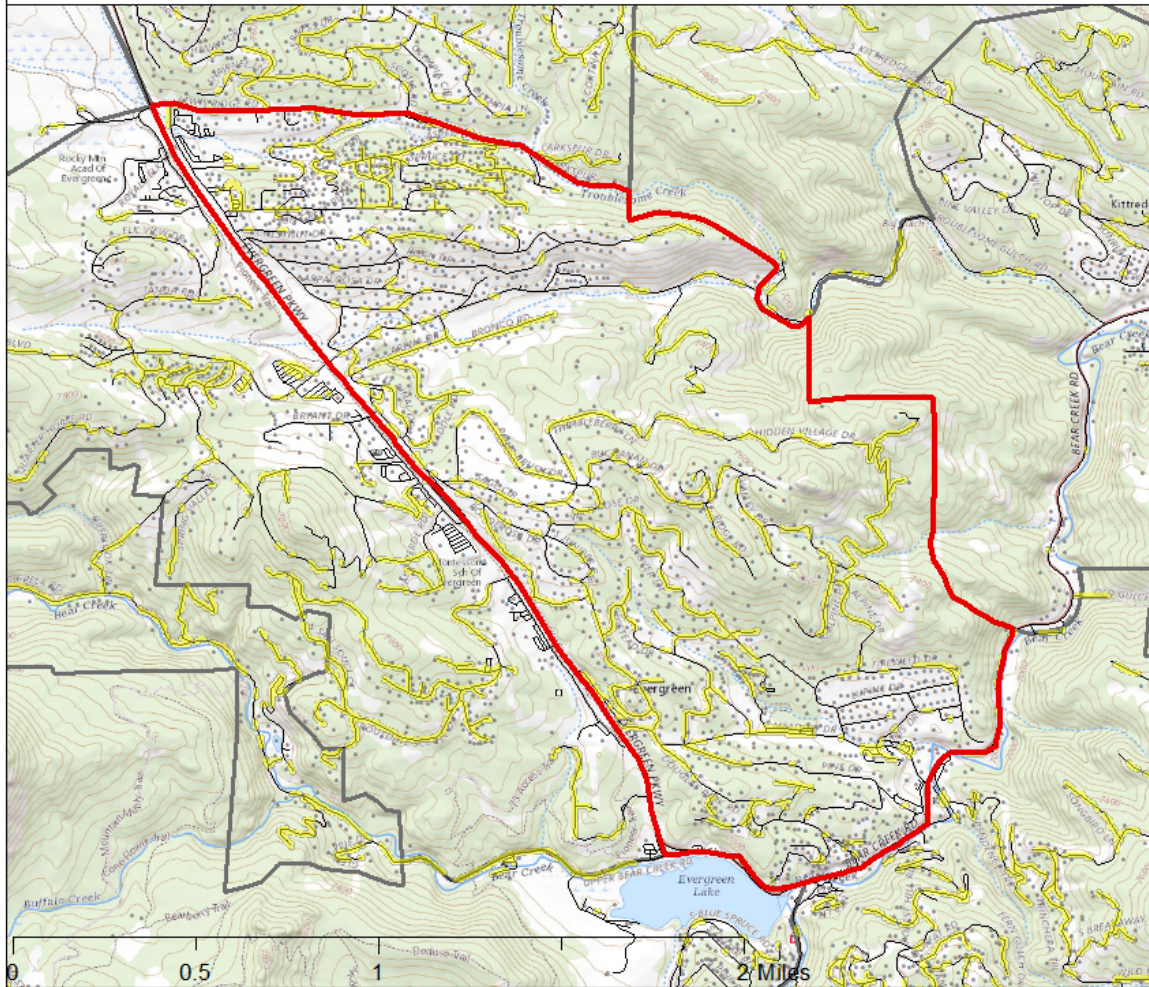
Plan Unit: Stagecoach/ Hiwan Hills

Stagecoach/Hiwan Hills has no modeled Evacuation Pinch Points. The area of highest concern for roadway survivability are the roadways closest to the downtown historic district, including Douglas Park Road and the shorter roads that stem from it. This area of higher population closer to the historic area will likely have evacuation delays and should be mitigated to reflect that fact.

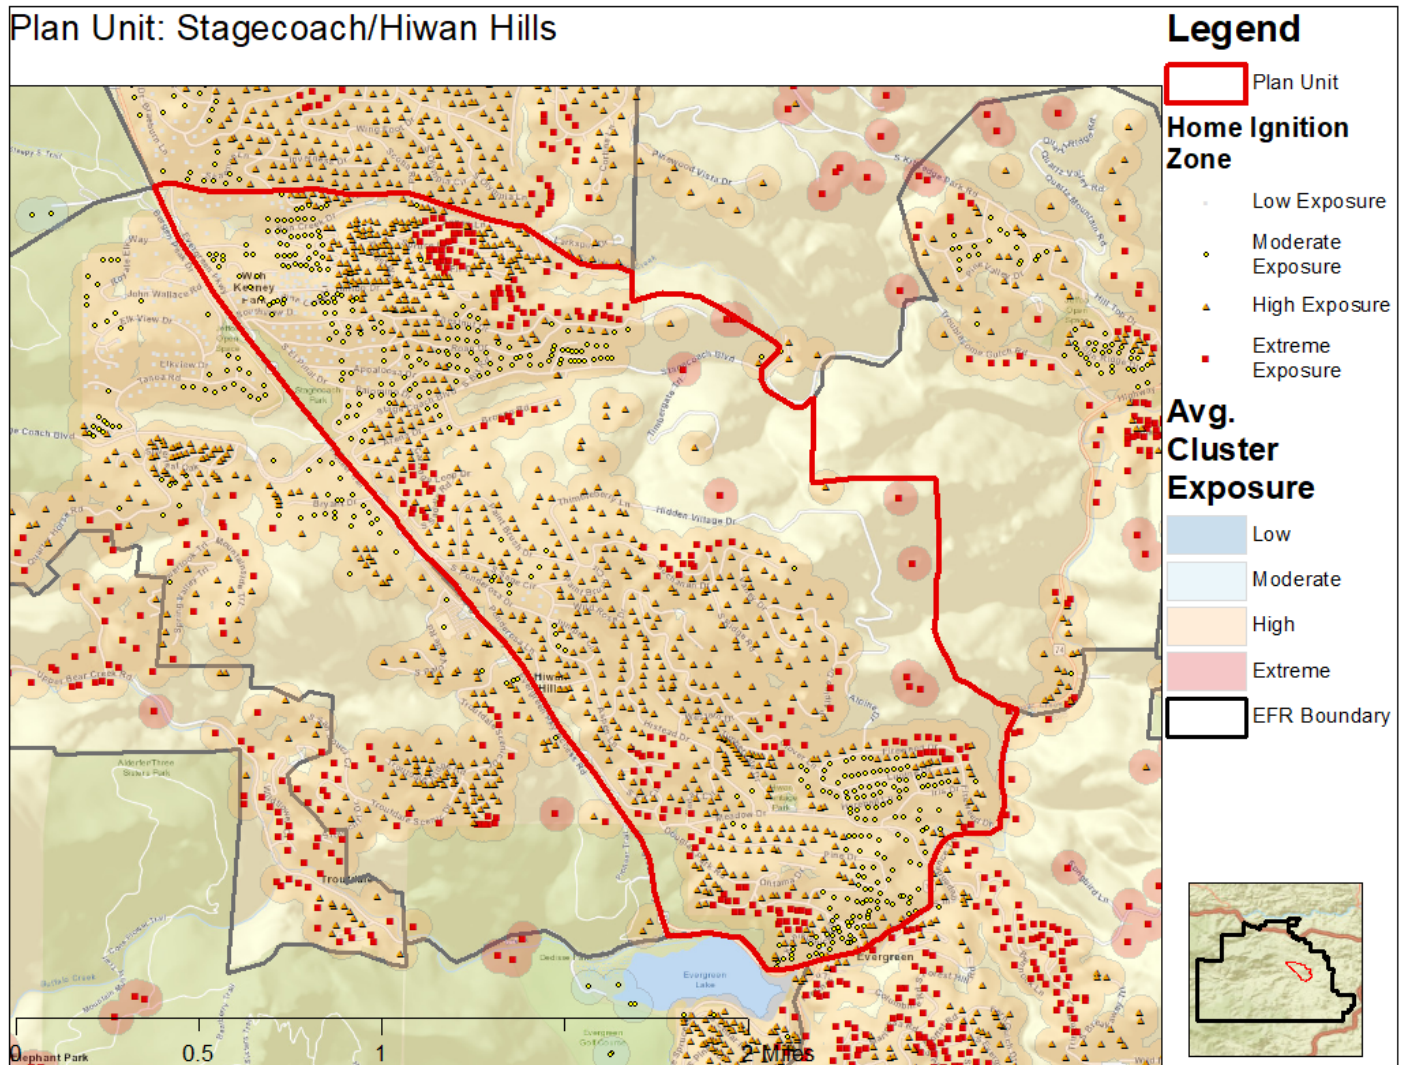
Plan Unit: Stagecoach/Hiwan Hills

Stagecoach/ Hiwan Hills has an average cluster exposure that is high, but many pockets of extreme structure exposures. Defensible space and home hardening will combat the risk to these areas and lower the collective risk. Locations are along Meadow Rue Road and Kinnikinick Road, Fireweed Drive, Pine Drive, Buchanan Drive, Carriage Loop Drive, and the areas surrounding Fir Drive to Spruce Drive.

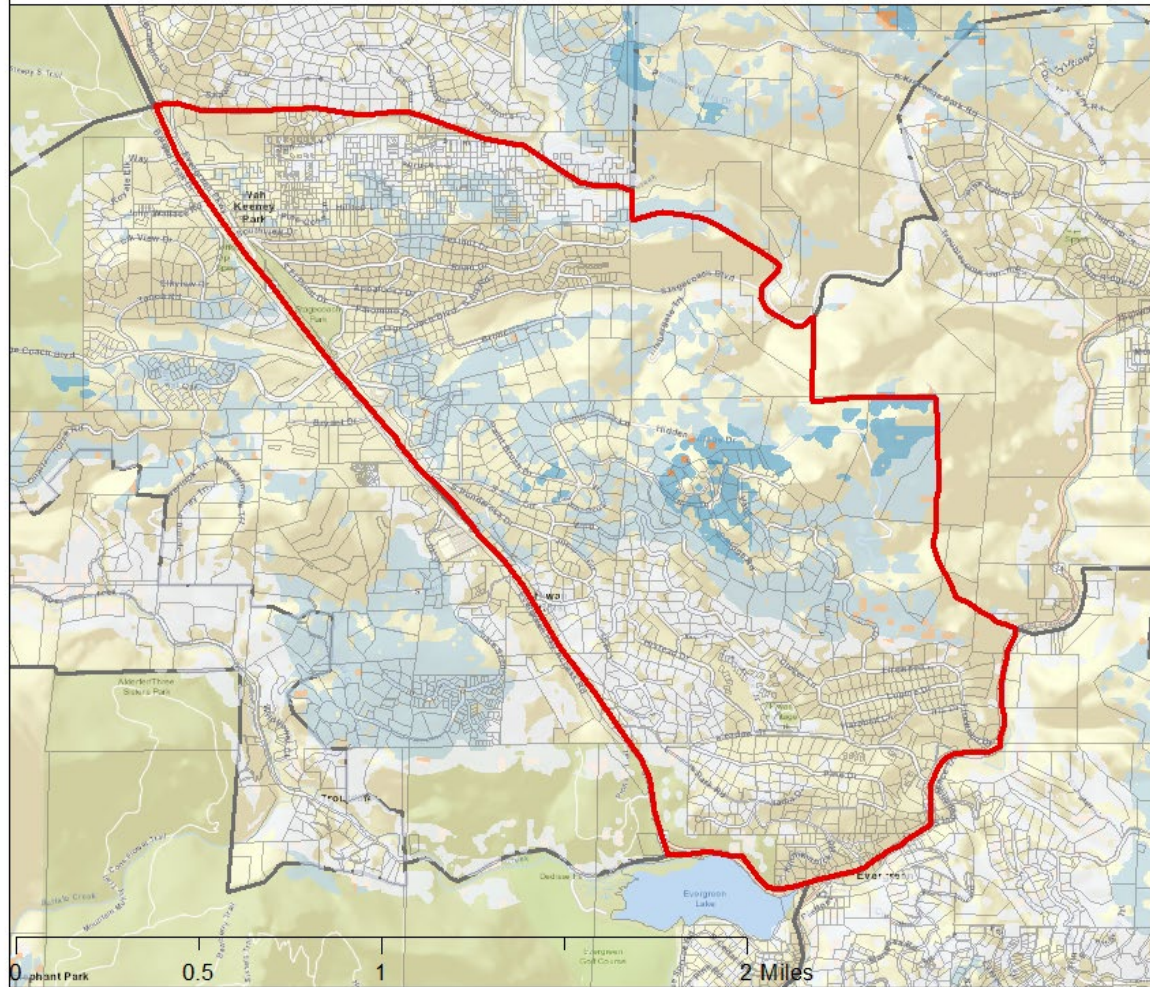
Plan Unit: Stagecoach/Hiwan Hills

Radiant heat and short-range ember exposure are displayed and filtered by accessible treatment areas (by slope and distance to a roadway). High to Extreme risk areas displayed in those maps are highest priority to protect from radiant heat and short-range spotting, however, this does not negate the need for defensible space treatment across the landscape.

As mentioned before the area around Buchanan Drive has topography and dense vegetation which contributes to pockets of extreme structure exposure. This area shows up from Hidden Village Drive to Ridge Road. This priority location for mitigation work will decrease risk in the area and provide improved tactical options for firefighters.

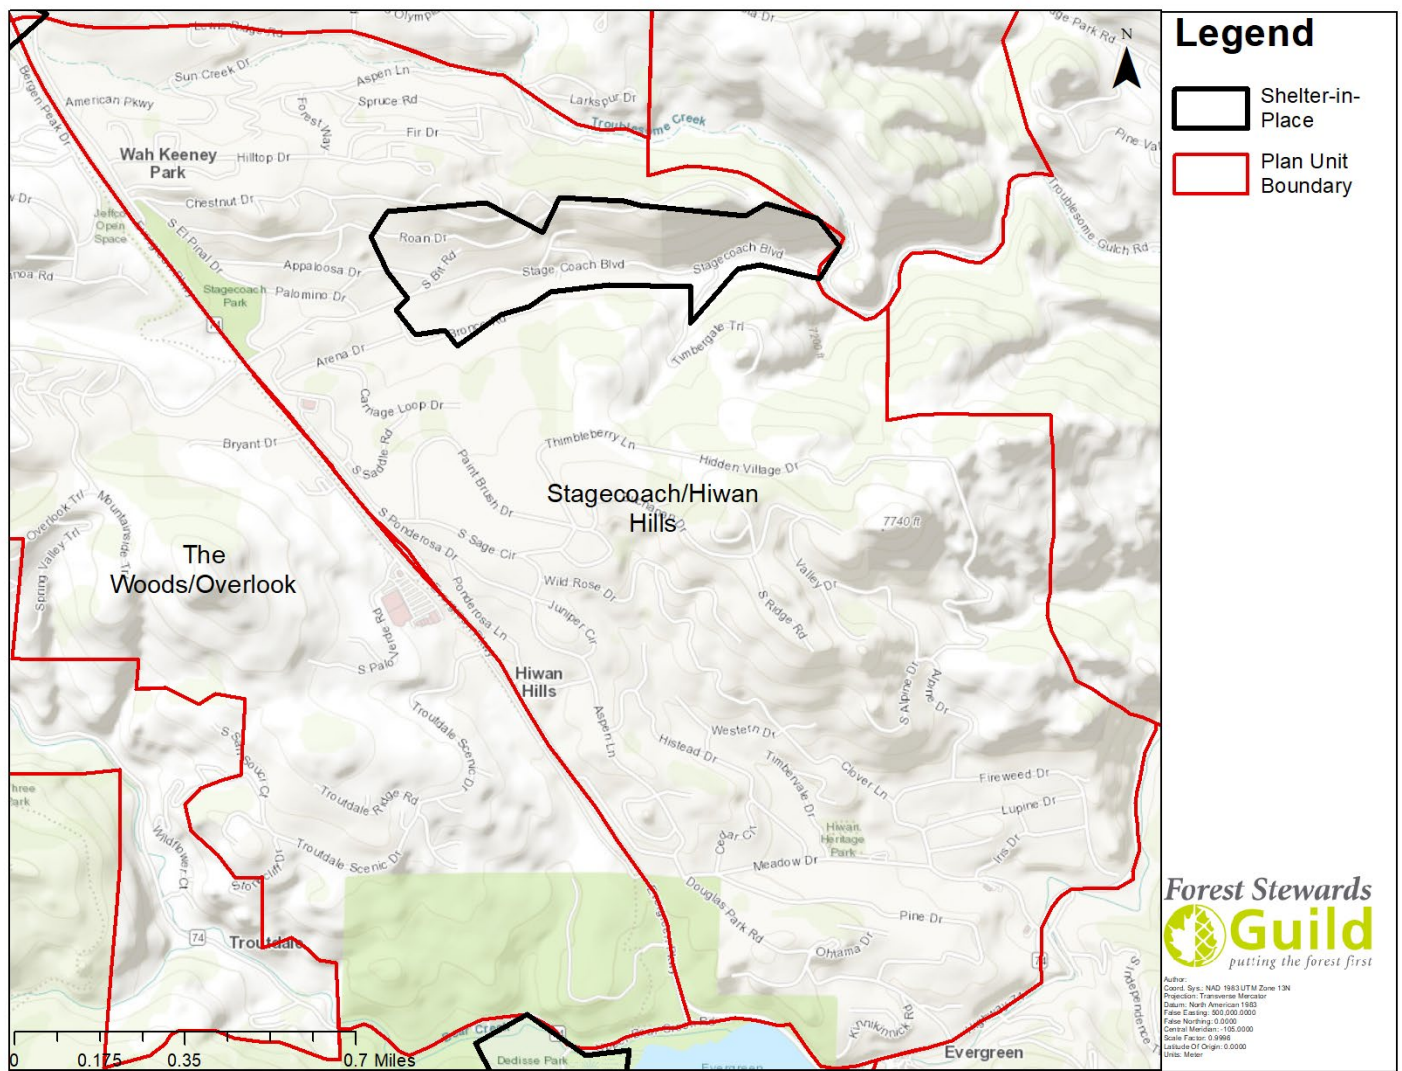
Shelter-in-place

In Stagecoach/ Hiwan Hills, there is a location that could be possible for shelter-in-place is along Stage Coach Boulevard, and around Buckboard Drive With some expansion and mitigation north and south into the dense wildland vegetation, this area could truly be viable. In this area, it is all private land, so Evergreen Fire Rescue will need the support of residents to create a shelter-in-place location in this neighborhood.

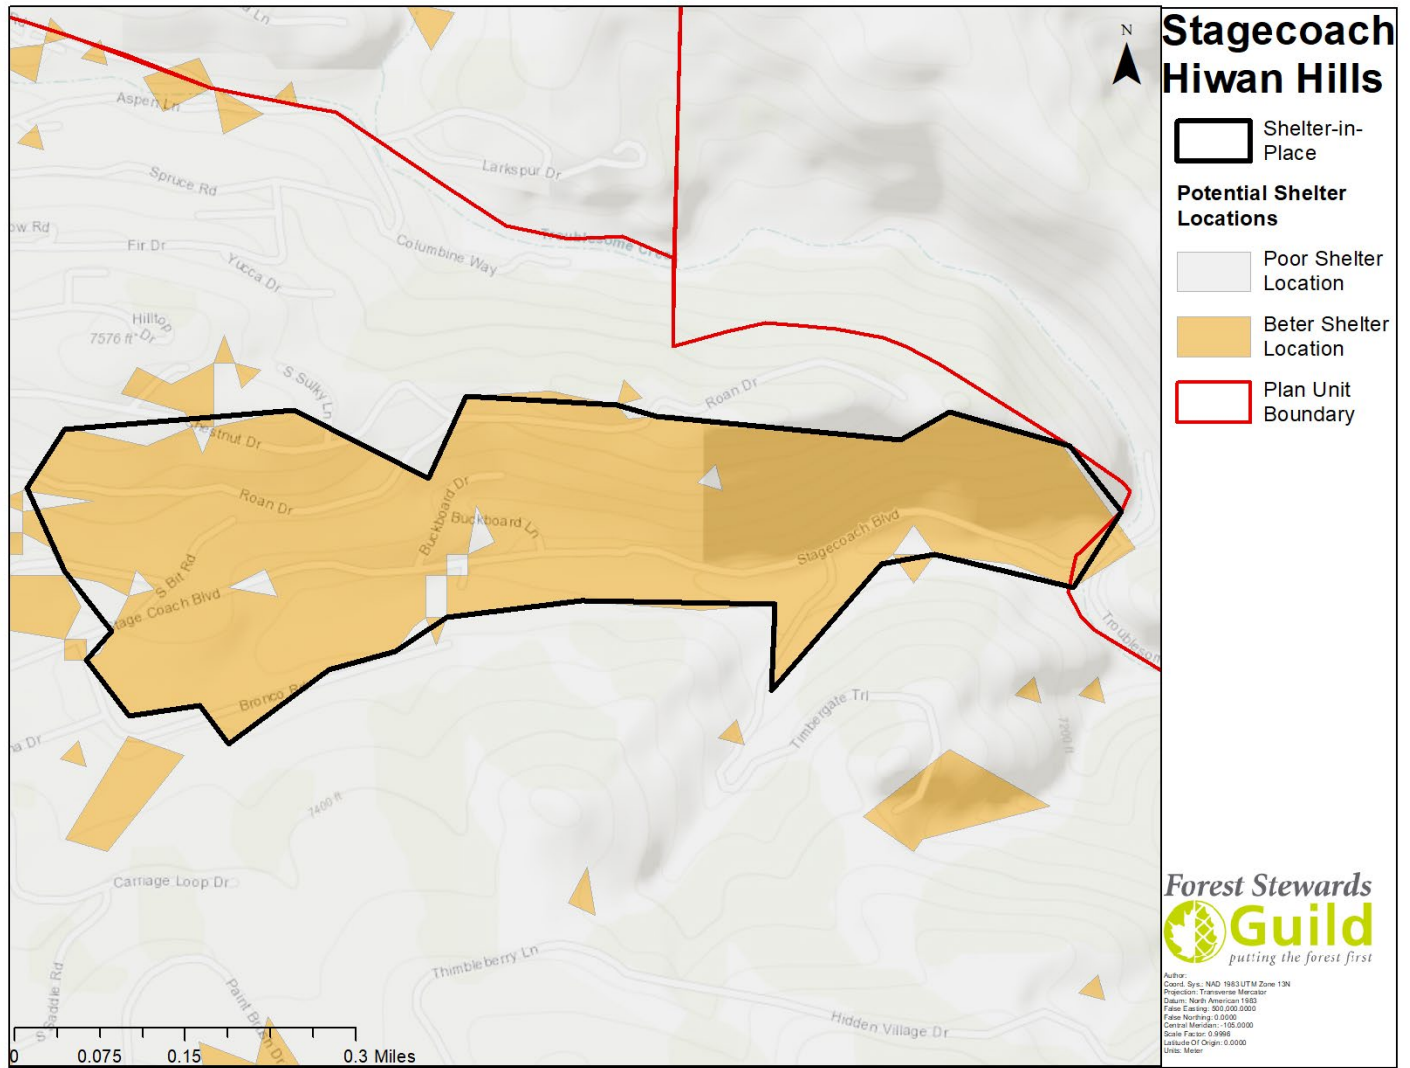
This is a close view of the proposed shelter-in-place location for Stagecoach/ Hiwan Hills. Poor shelter locations within this boundary are areas where fuel loading is still too high. These areas should be mitigated to improve the overall shelter location.
