BEAVER BROOK – PLAN UNIT 15

Rating: Extreme

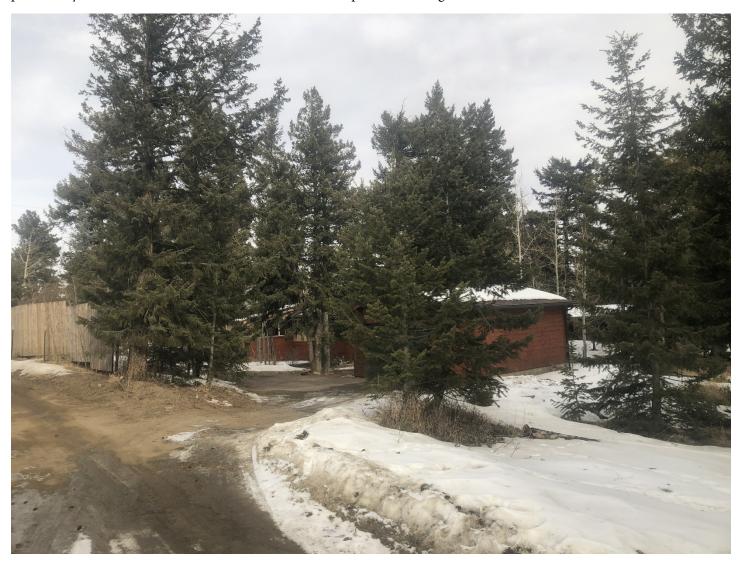
Wildland fuels here are low density Ponderosa Pine forest stands and Aspen with some pockets of mixed conifer forest structure. Many private properties show evidence of mitigation work, but surrounding or adjacent fuels are dense and problematic for effective firefighter response. Evidence of thinning appears to be older and should revisited and extended further away from homes. Many residences appear to have part-time occupancy, possibly on a monthly or weekend basis, particularly further north. Road access is limited in some portions of neighborhood towards Beaver Lane.

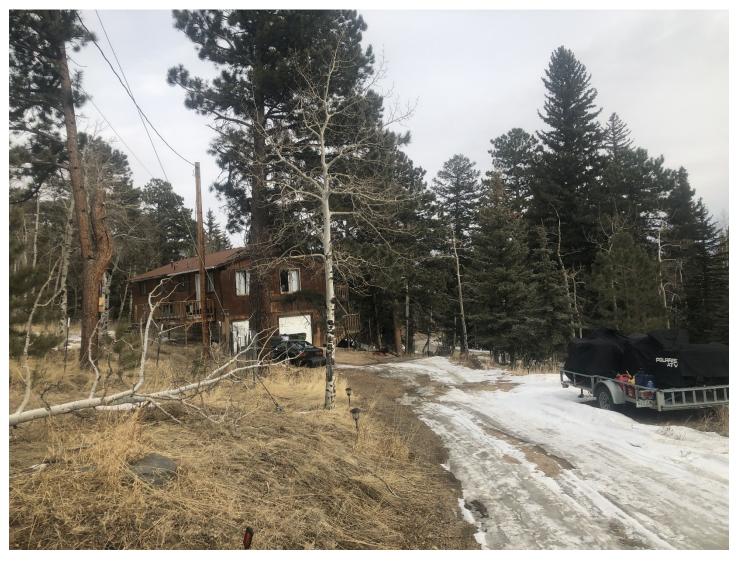
Smaller cabins are on the north end in higher densities. This area should work to improve defensible space and improve roadway condition for fire equipment and evacuation.
