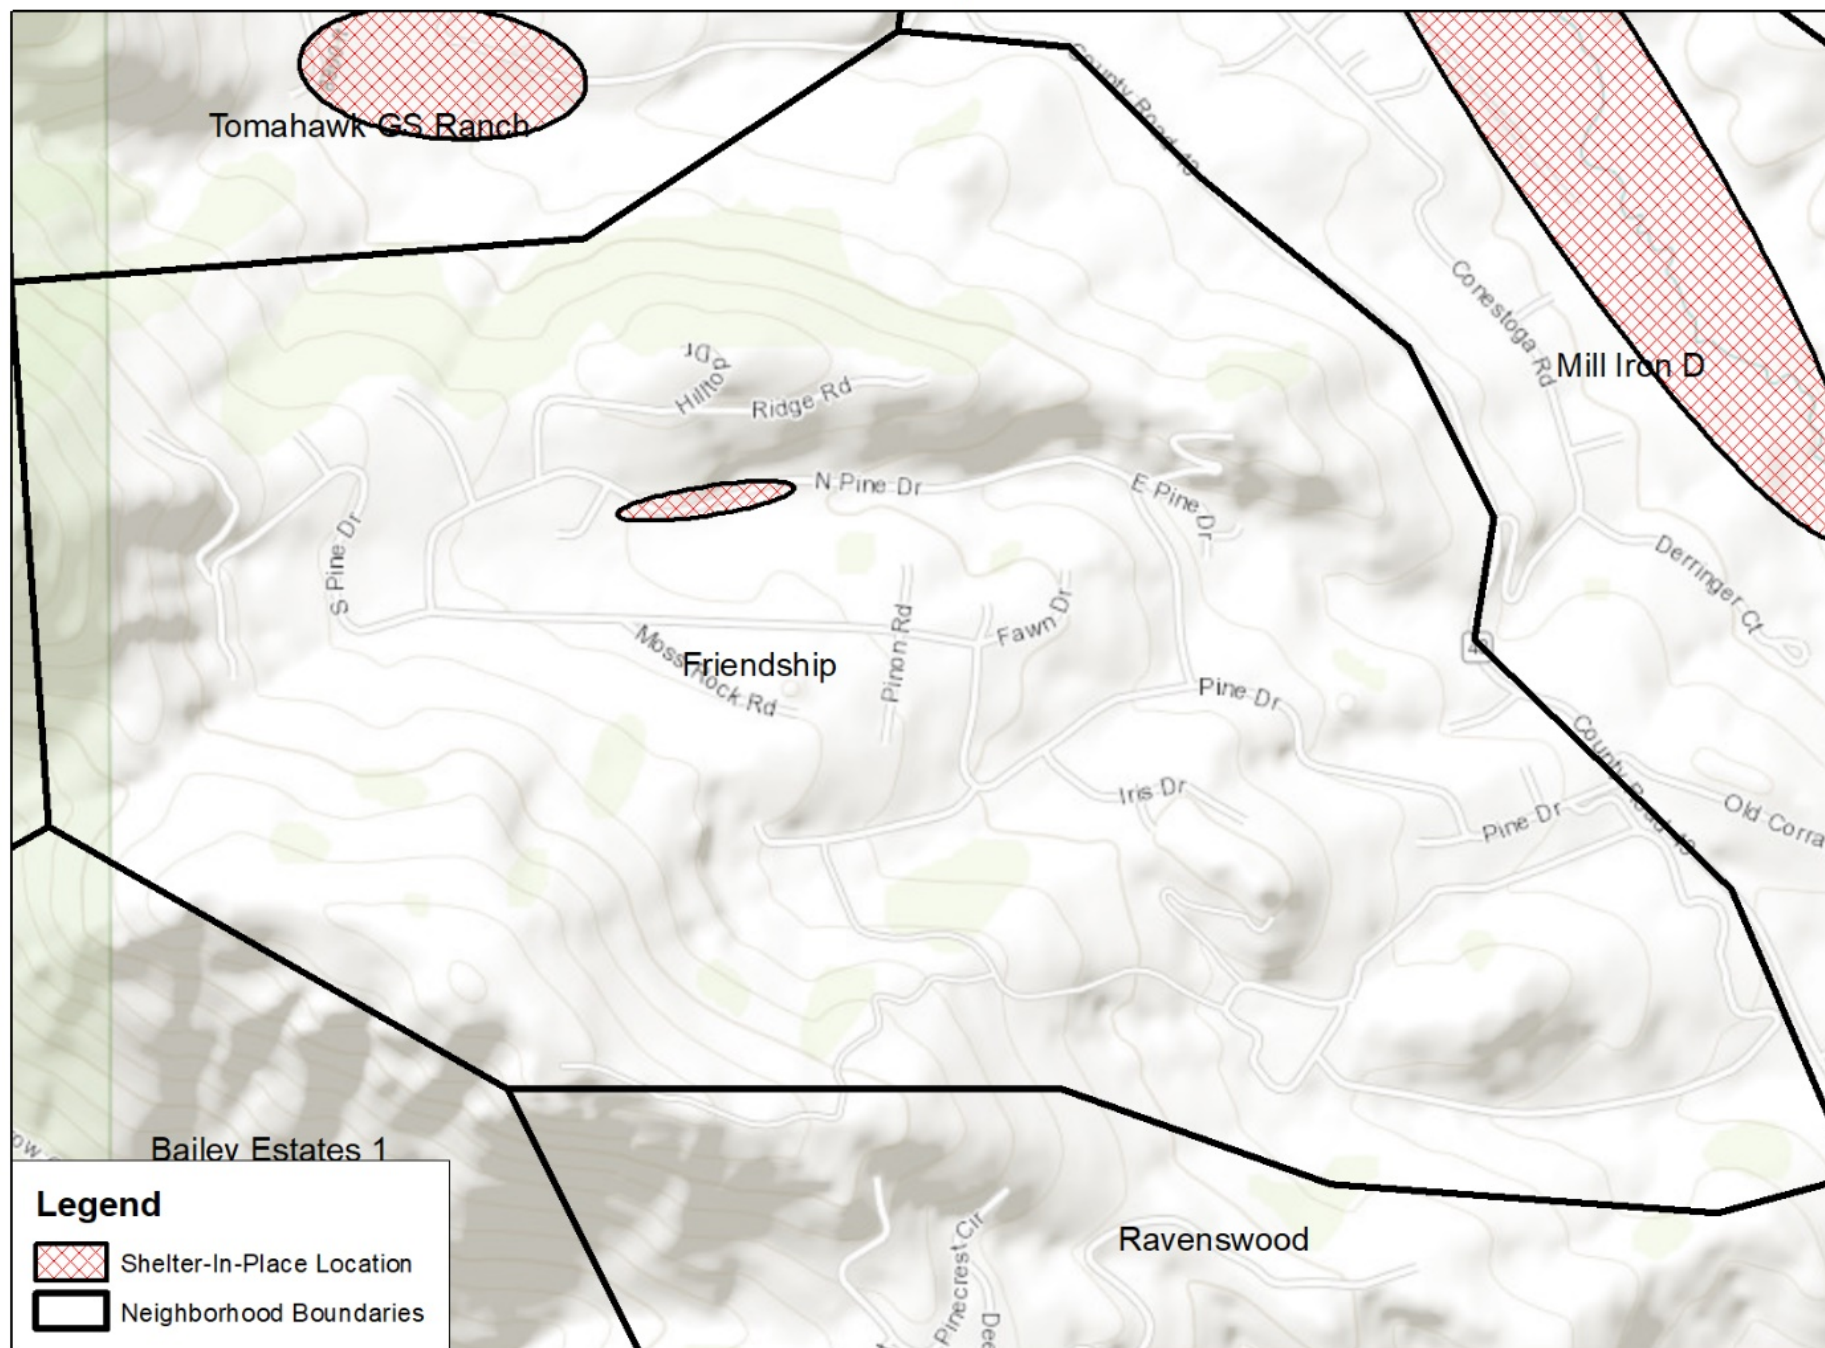
## Shelter-in-Place Proposed Location

Friendship has some evacuation congestion getting onto County Road 43 and plenty of non-survivable roadway. This needs to be mitigated along with a Shelter-in-Place location – the location pictures for Friendship is small and needs to be mowed to be viable. Homes on the edges of the neighborhood are at greatest exposure to radiant heat. There are structures in Friendship and all are exposed to long-range embers.

**High Priority Implementation Project:** An improved Shelter-in-Place location, accounting for slope, is necessary in Friendship. With predicted congestion along County Road 43, residents of this neighborhood need to have an emergency plan if evacuation does not go as planned.

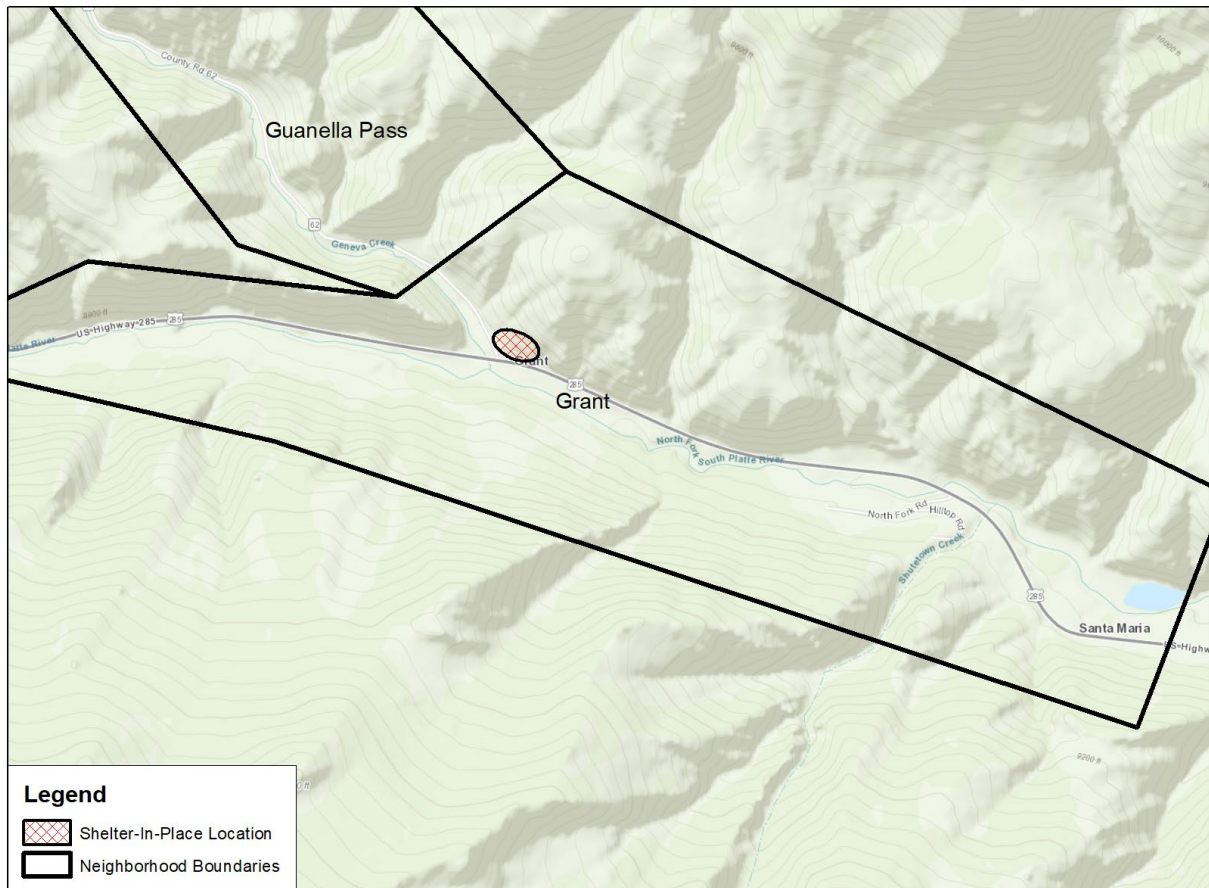
Shelter-in-Place Proposed Location

At the intersection of US 285 and CO 62, there is some shelter-in-place potential that could be improved by treatments to the slopes above. Roadways in Grant are not a large concern for treatment as they are currently in good shape and few homes are exposed to radiant heat or short-range embers. There are 83 structures in this neighborhood and all are exposed to long-range embers.

**High Priority Implementation Project:** Thinning treatment to the North facing slope that overlooks 285 would be a large-scale project that would have a great impact in this area. The design of this treatment should improve tactical options for backing a fire down the slope and preventing its spread further East. In Ponderosa and Mixed-Conifer pockets, the stand should be thinned to 15-foot tree spacing. In Spruce-Fir or Lodgepole pockets of forest, the treatment should be thinned by the guidelines in Appendix 9.

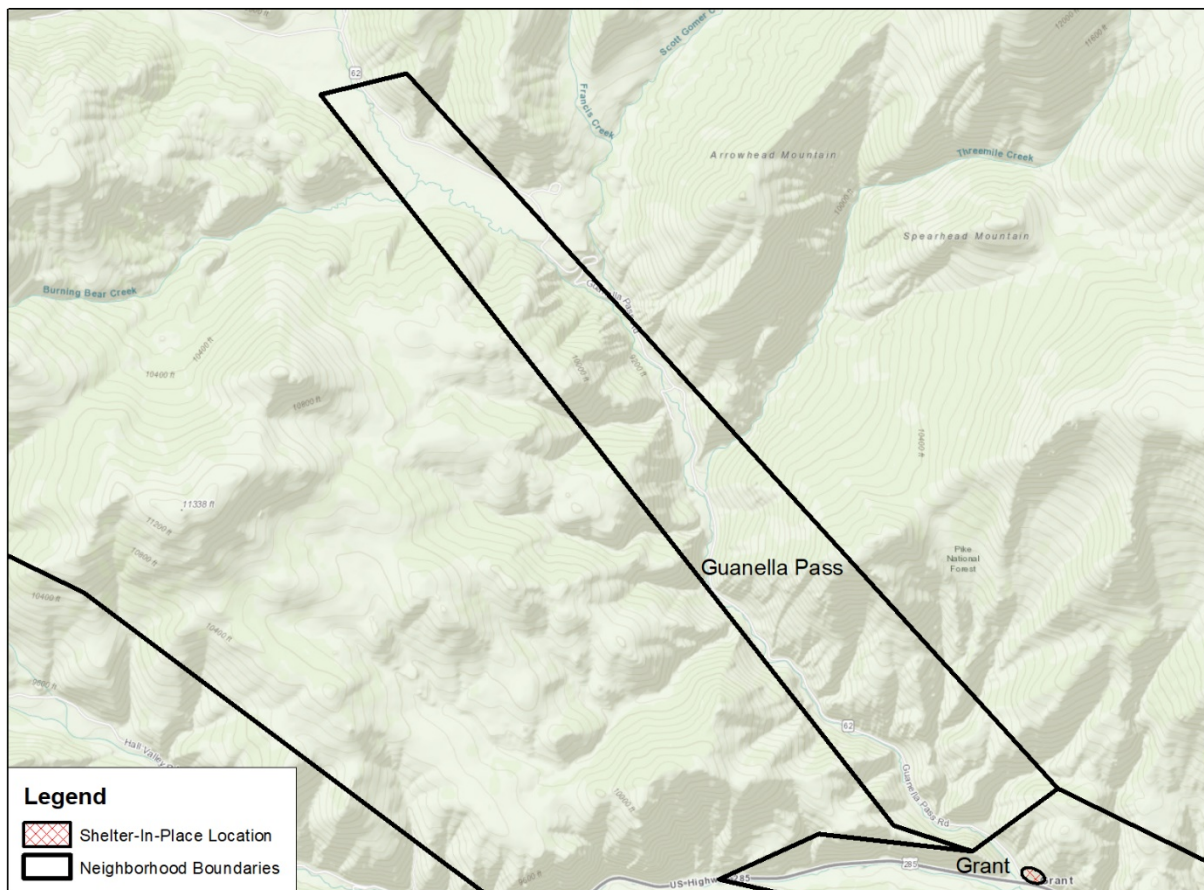
Shelter-in-Place Proposed Location

There is no current place to recommend a shelter-in-place location, but with a proximity to US 285, residents or visitors could travel away from an approaching wildfire. Few homes are at risk

**High Priority Implementation Project:** Roadway Thinning treatment along County Road 62 to facilitate egress. Treatment distance from road should consider the extreme slope at points in the pass. Locations of 30% slope or greater must be treated first with 320 feet of thinning treatment. This treatment is only intended to facilitate egress and would not prevent a wildfire from quickly jumping across the canyon and moving East. To use Guanella Pass as a linear topographic feature to improve tactical options, fuel thinning should occur at the ridgetop to the West.

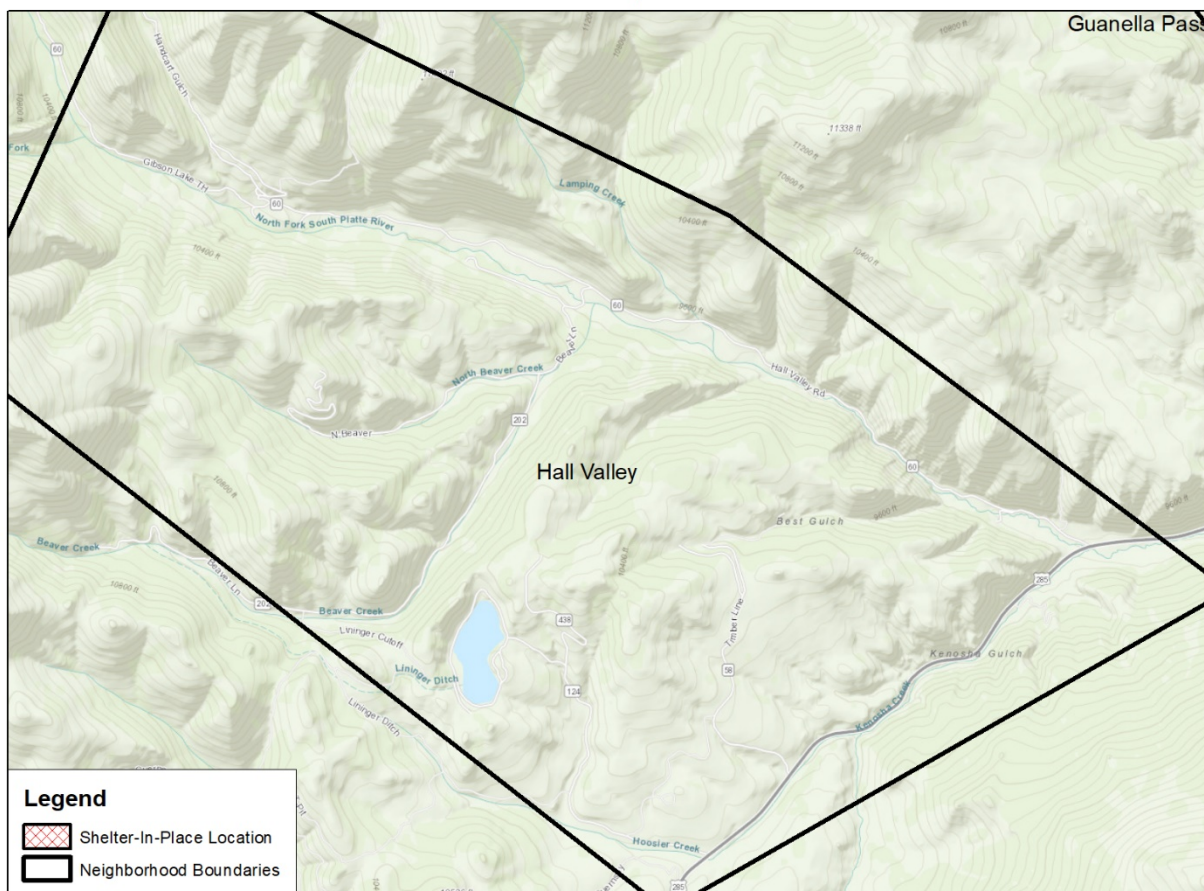
Shelter-in-Place Proposed Location

There is no current place to recommend a shelter-in-place location, but with a proximity to US 285, residents or visitors could travel away from an approaching wildfire. Few homes are at risk

**High Priority Implementation Project:** Roadway Thinning treatment along County Road 60 to facilitate egress. Treatment distance from road could be  $\frac{1}{4}$  mile for this fuel type. Recommendations come from Appendix 9, Lodgepole Management Guidelines for Land Managers in the Wildland-Urban Interface. This treatment is intended to improve egress. To develop tactical lines of engagement in this fuel type, the treatment should be more aggressive to mimic stand replacement.

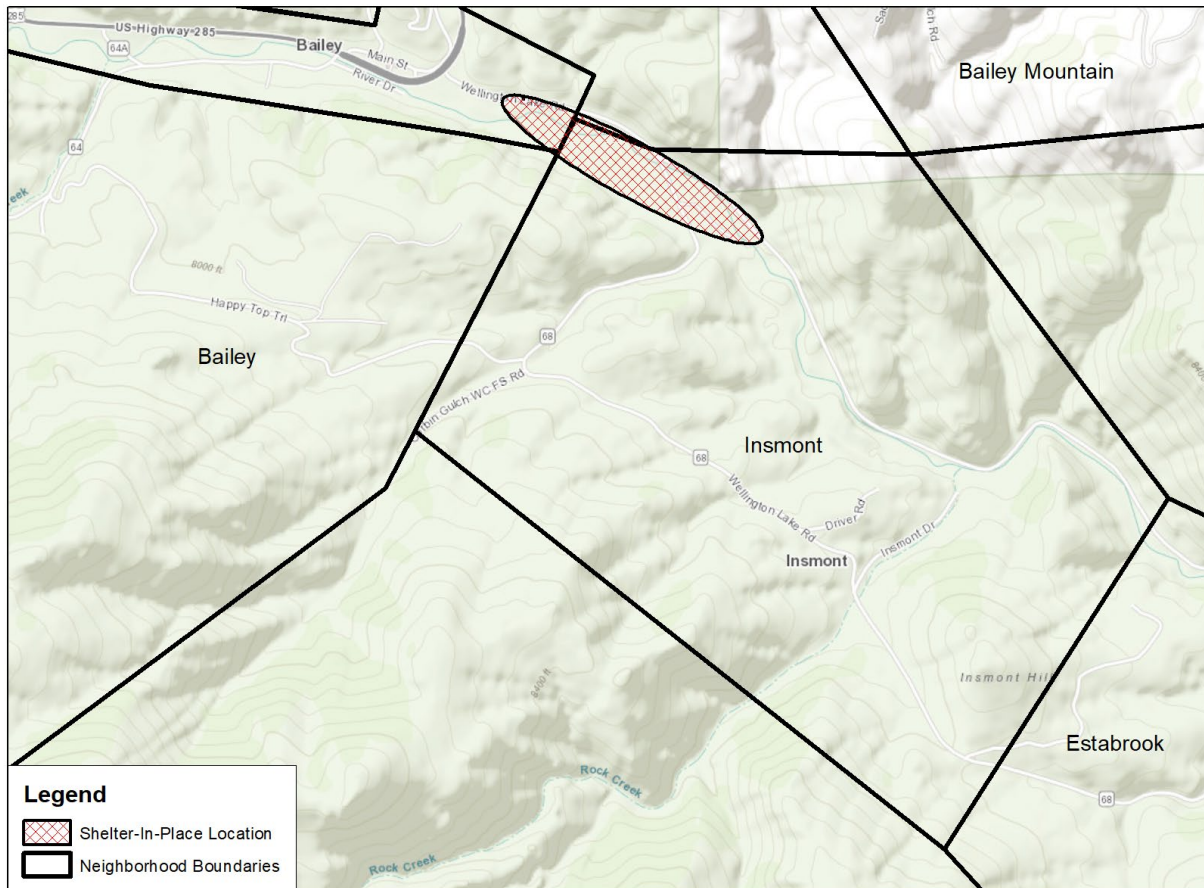
Shelter-in-Place Proposed Location

Insmont has no Evacuation Pinch Points but lots of roadway is non-survivable during 90<sup>th</sup> percentile fire weather conditions. With shorter evacuation times, Insmont is in better shape than other neighborhoods South of Bailey. Most structures are currently exposed to short-range spotting potential. All 31 structures are exposed to long-range embers.

**High Priority Implementation Project:** The area around Farmers Union has a great meadow to anchor from. Improvements to this area along County Road 68 should be a thinning treatment that spans from the roadway, to improve roadway survivability conditions, into fuels surrounding to improve risk to structures and shelter-in-place condition. This treatment would improve conditions to Bailey and the Commercial District as well. This should connect with Proposed Landscape-scale treatment B and span wide of at least 350-feet.

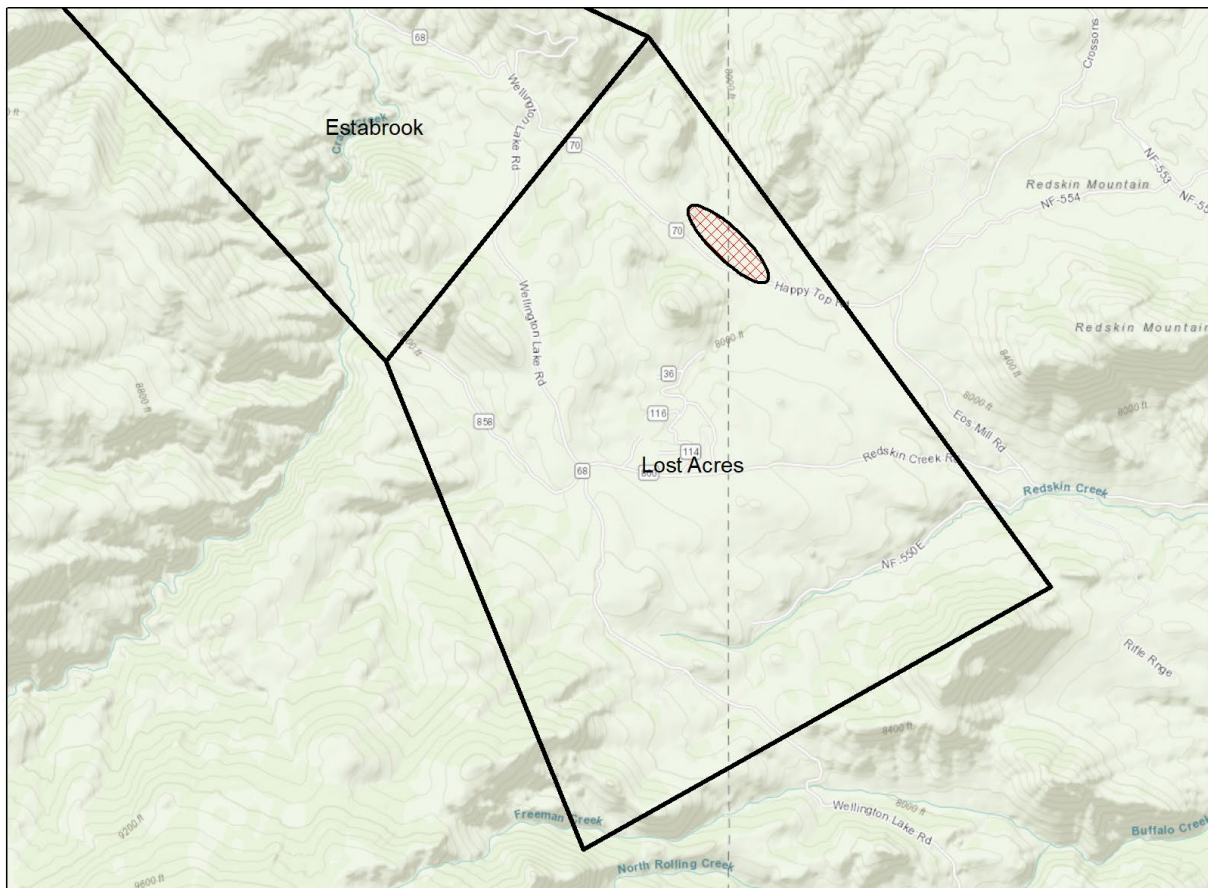
Shelter-in-Place Proposed Location

This neighborhood is smaller, on the furthest south edge of Platte Canyon Fire Protection District, with 27 total structures mapped. Homes are tucked into the forest with no obvious Home Ignition Zone improvements. The nearest shelter for these residents is the meadow near Happy Top Road, but this is only viable in a worst-case scenario and would not house the neighborhood. Evacuation out of this neighborhood entirely is preferred. There are not a lot of bright spots in this neighborhood for home survival as most housing material is quite flammable. Roads are extremely narrow, winding, and uneven. Within the neighborhood, streets and addresses are not marked well, and homes are stacked close together with no defensible space among the heavier timber. Evacuation will be difficult due to roadway condition, even though population and congestion is lower. The above photo is the best area with the least ladder fuel. Between Estabrook and Lost Acres is a roadway covered by heavy fuel that would not be survivable during a wildfire. The vegetation is an intermix of Ponderosa and Lodgepole pine. Major work needs to be done in this area if homes or trees are to survive a wildfire.

**High Priority Implementation Project:** Use Appendix 8 to improve Shelter-in-Place locations. Fuel loading in this neighborhood is extremely high and a shelter location needs to reflect this with sufficient size. Currently there is a meadow that could be anchored to and expanded, but an additional area close to population centers in Lost Acres would work too. Whatever the location, slope needs to be adequately considered for resident's protection.

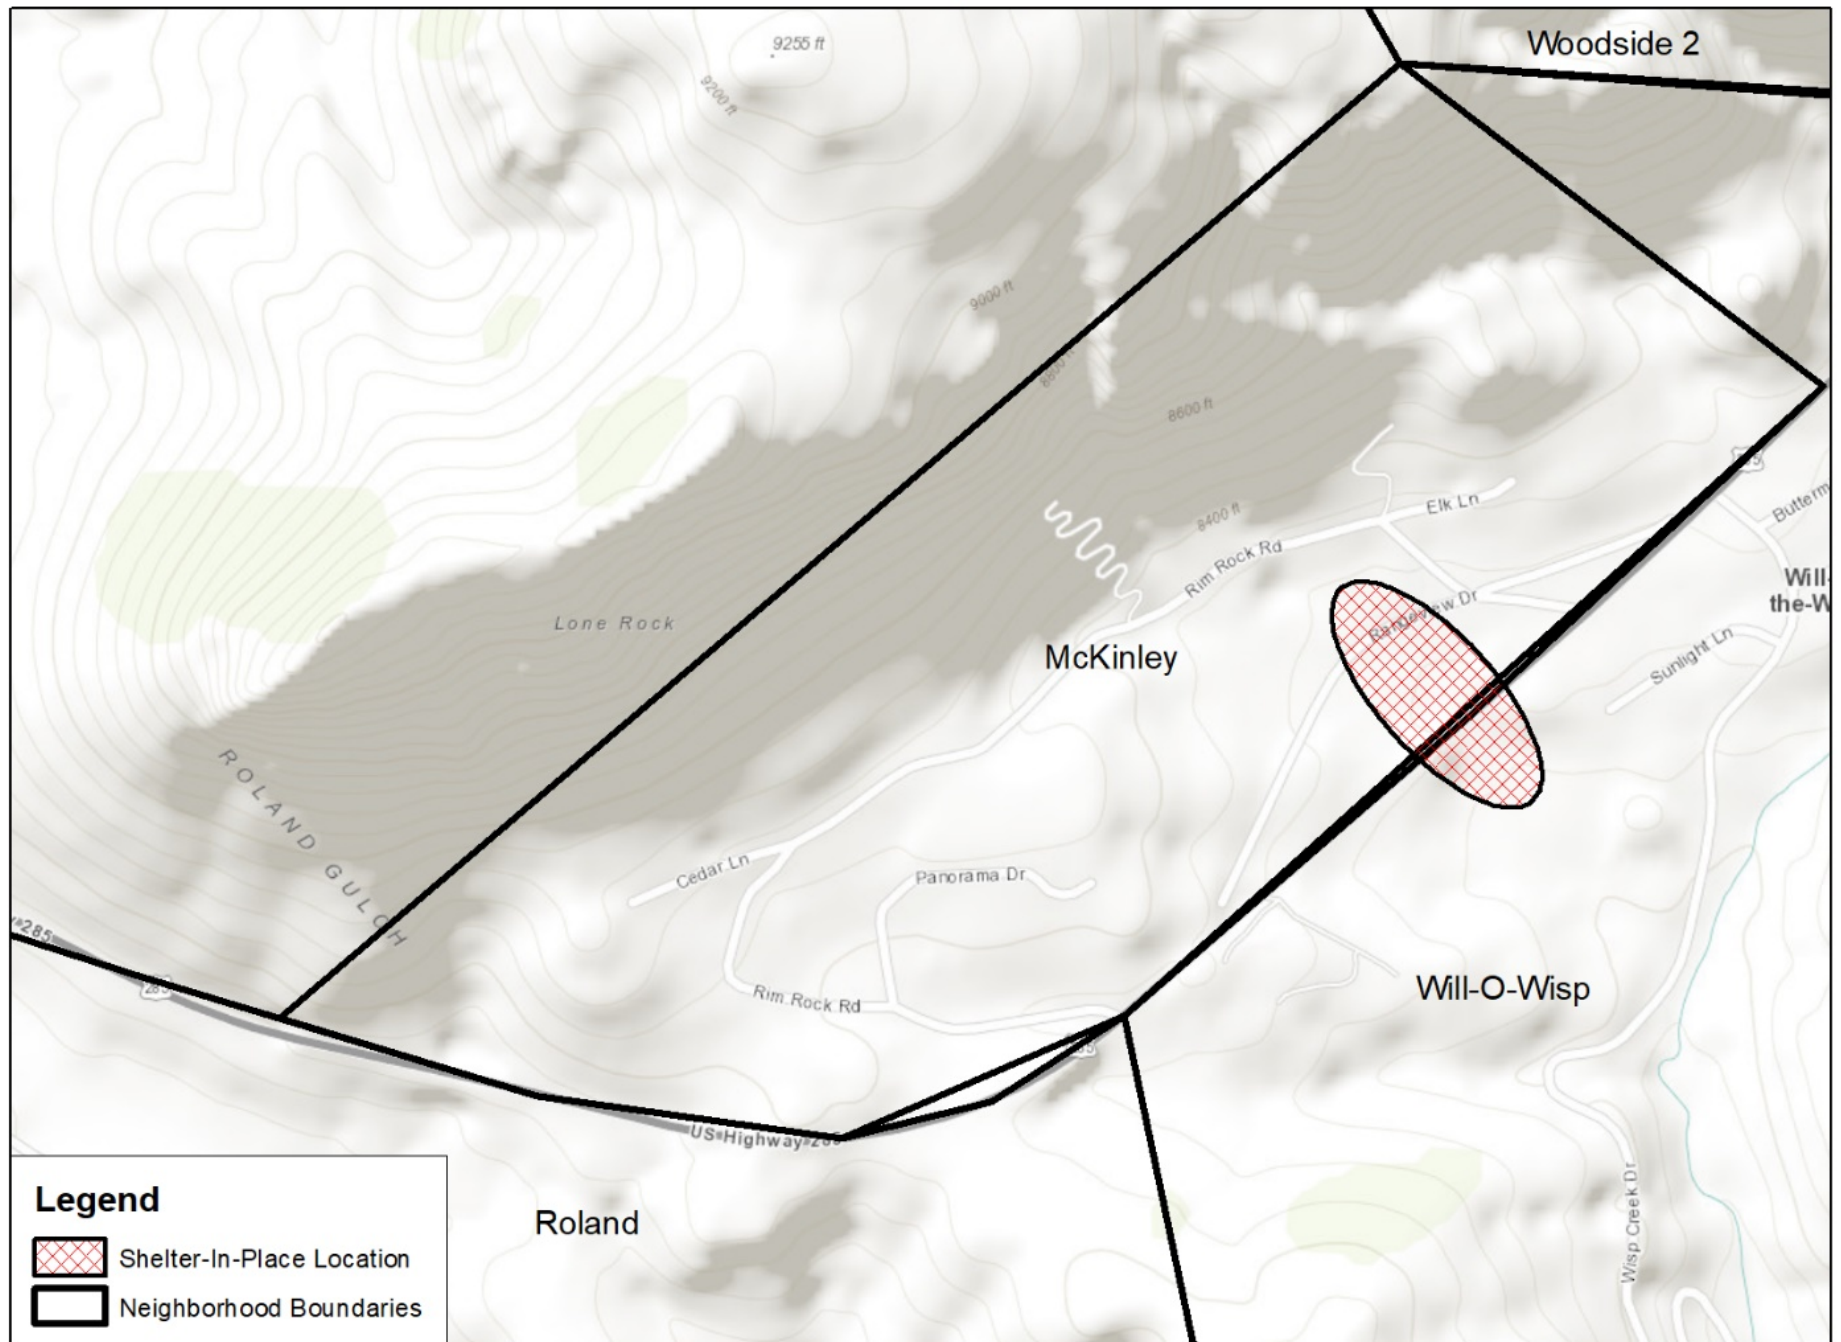
## Shelter-in-Place Proposed Location

There are 77 structures in McKinley. So few structures and roadways are at risk of intense fire behavior in this neighborhood, the main evacuation concern would be related to any traffic backup on US 285. Rates of spread in this grass dominated fuel type would be the main fire behavior factor to be aware of. Home Hardening practices will be very successful in this neighborhood, as Defensible Space is already present.

**High Priority Implementation Project:** The best treatment for McKinley would be to improve Shelter-In-Place locations so that residents from other communities could also shelter there. Any modifications should be made to specifications outlined in Appendix 8 and should account for slope.
