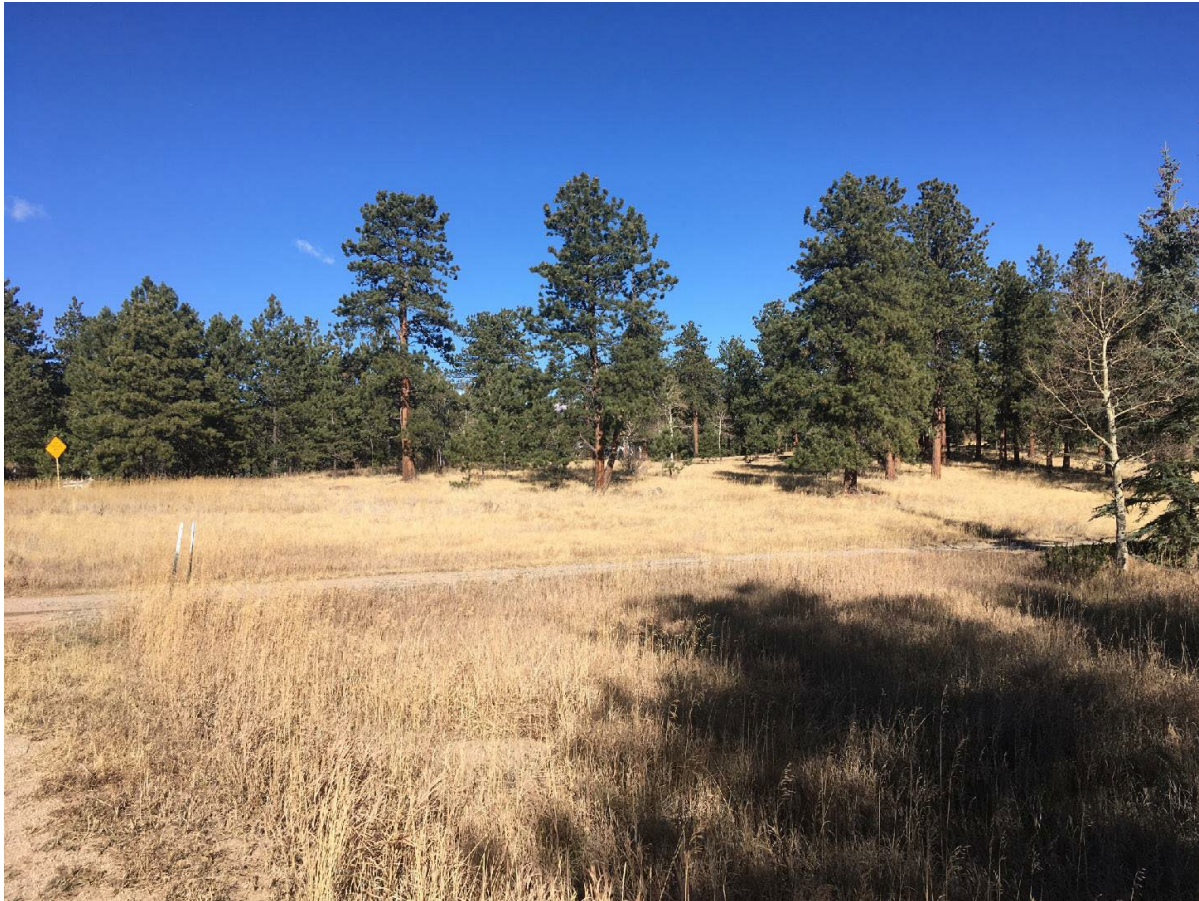
Mill Iron D was mitigated when the neighborhood was built which improves its current state. Roadways and fire access are great, with homes spaced appropriately and shallow terrain. Some green reflective road signs and addresses are present, but this would be a low-cost improvement to make. Ponderosa spacing is adequate and many homes have defensible space. Residents of this neighborhood should encourage their un-mitigated neighbors to do some work to bring the entire neighborhood to a very safe and defensible space. The Hazard Assessment value is 1.

With Deer Creek running to the East of this neighborhood, rates of spread on the ground are more of a concern than running crown fire for fire behavior. Within the neighborhood, the only area that needs considerable improvement is around Old Corral Road. It is important to note that this neighborhood is currently in good condition, but this status needs to be maintained through limbing and thinning as able. There are 113 structures here, all at risk of long-range embers.

High Priority Implementation Project: Thinning treatments at minimum distances can be completed around Old Corral Road to improve the roadway survivability and lower the risk to homes in that area. Thinning treatments should follow the standards set out in Appendix 7.

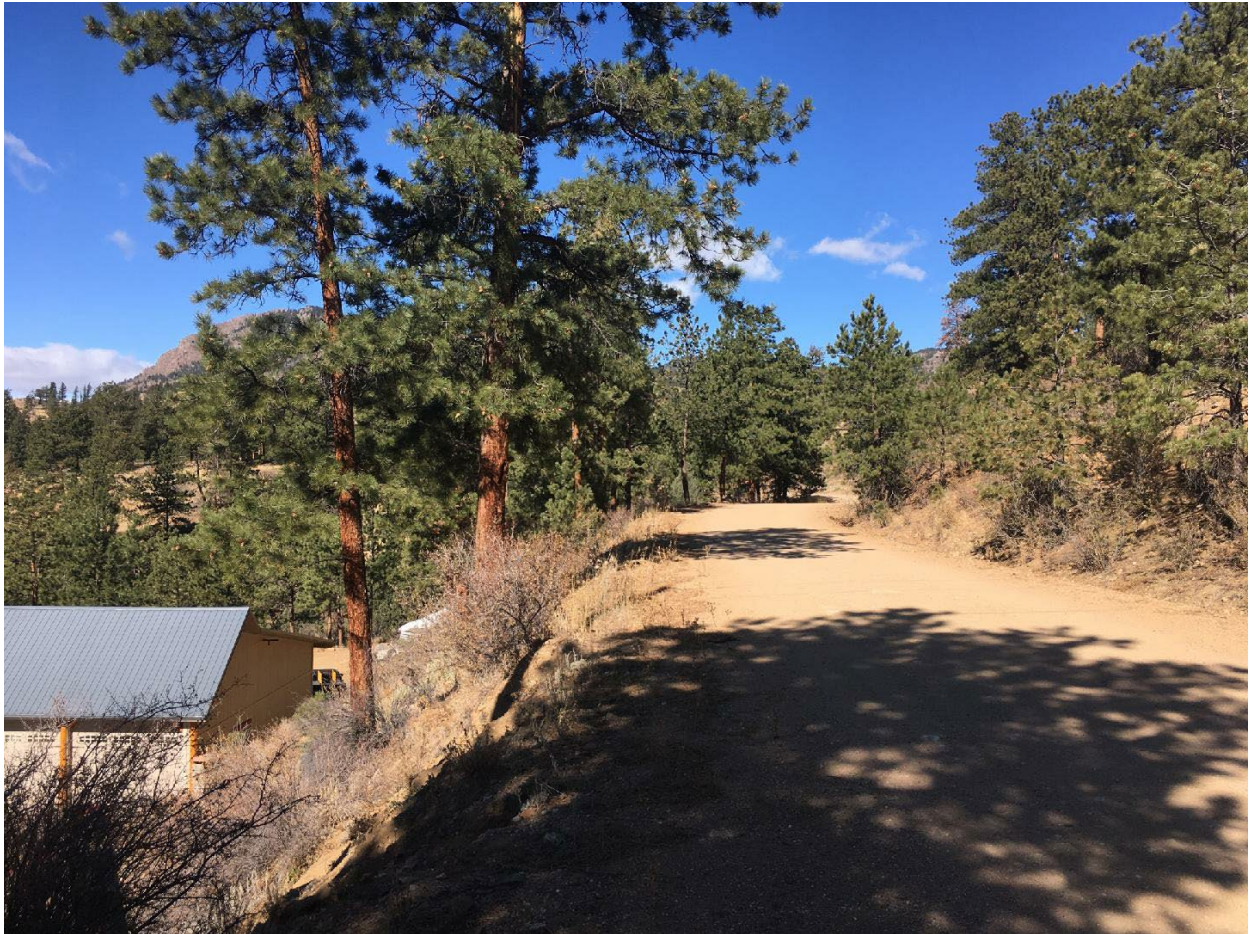
Park is like many neighborhoods in Platte Canyon that need some work to overcome steep slopes and heavy fuels. Homes further away from 285 placed on ridge tops are at great risk of home loss and need to consider defensible space distances based upon fuels below their homes. New homes should not be built within 30 feet of a steep slope. Housing stock is newer, but home hardening practices need to be utilized and wooden decks need to be treated. Access is difficult as well up Pine Hollow and Spring Valley, especially with steep driveways. Access challenges makes it more difficult for firefighters to defend homes in this neighborhood. There is nowhere to shelter within the neighborhood and one exit for evacuation, making evacuation planning a priority. Access issues give Park a Hazard Assessment rating of 3.

There is no obvious place to shelter in Park, though their evacuation is relatively short, depending on the conditions of 285. Non-survivable roadway covers less in this neighborhood,

but home exposure is high. There are 23 structures in Park, all exposed to long-range embers. This neighborhood's risk would dramatically change with linked defensible space work and some roadway clearing. Slopes are an important consideration for residents in this neighborhood, as fire races upslope quickly.

High Priority Implementation Project: Roadway thinning to improve non-survivable roads is top priority for Park. Major roads follow topographic lines and a thinning treatment could serve a dual purpose. Thinning treatment of 350-feet would improve egress options for residents in an emergency scenario, and provide tactical lines of engagement before a wildfire reaches Mount Bailey.

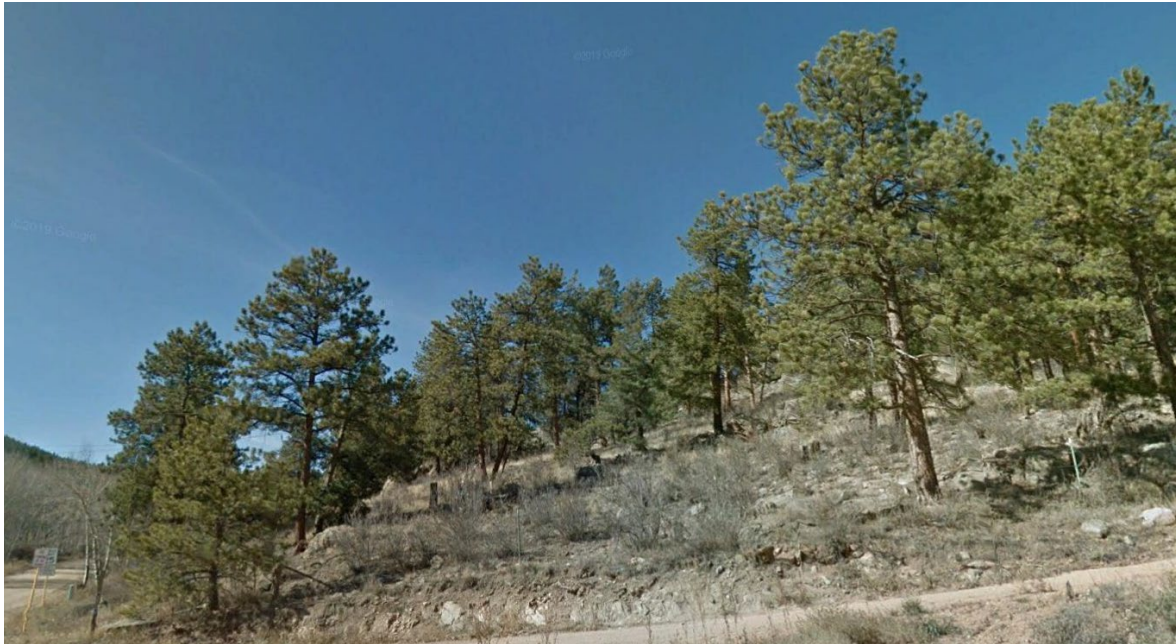
Entering Ravenswood, a forested gulch leads upslope to less dense Ponderosa, all upslope of Crow Gulch, a very flammable ravine. Homes mostly sit on ridgetops, with no apparent defensible space. Housing stock is older with Class A roofs and wooden construction materials. One way out of the community leads a short distance to 285 and is the closest neighborhood to Platte Canyon Fire Protection District Station #2, which is staffed 24/7. Due to the combination of home construction materials and potential difficulty to defend this neighborhood with less density in forest structure, the Hazard Assessment value is 2. There are 52 structures mapped in Ravenswood.

The homes in Ravenswood at risk of radiant heat and short-range spotting are near to some Ponderosa clusters that could be mitigated to dramatically change the structure exposure. The vegetation along Summitt Drive coupled with steep slopes put homes in that vicinity at the greatest risk. The evacuation corridor out Delwood Drive is also at risk due to vegetation in the drainage alongside it.

High Priority Implementation Project: To protect structures, a neighborhood-wide thinning treatment is recommended, particularly between Summitt Drive and Ravenswood Court/Pinecrest Circle at the top of the neighborhood. This could lessen the risk to this neighborhood's structures, and connect to proposed district-wide fuels treatment C.

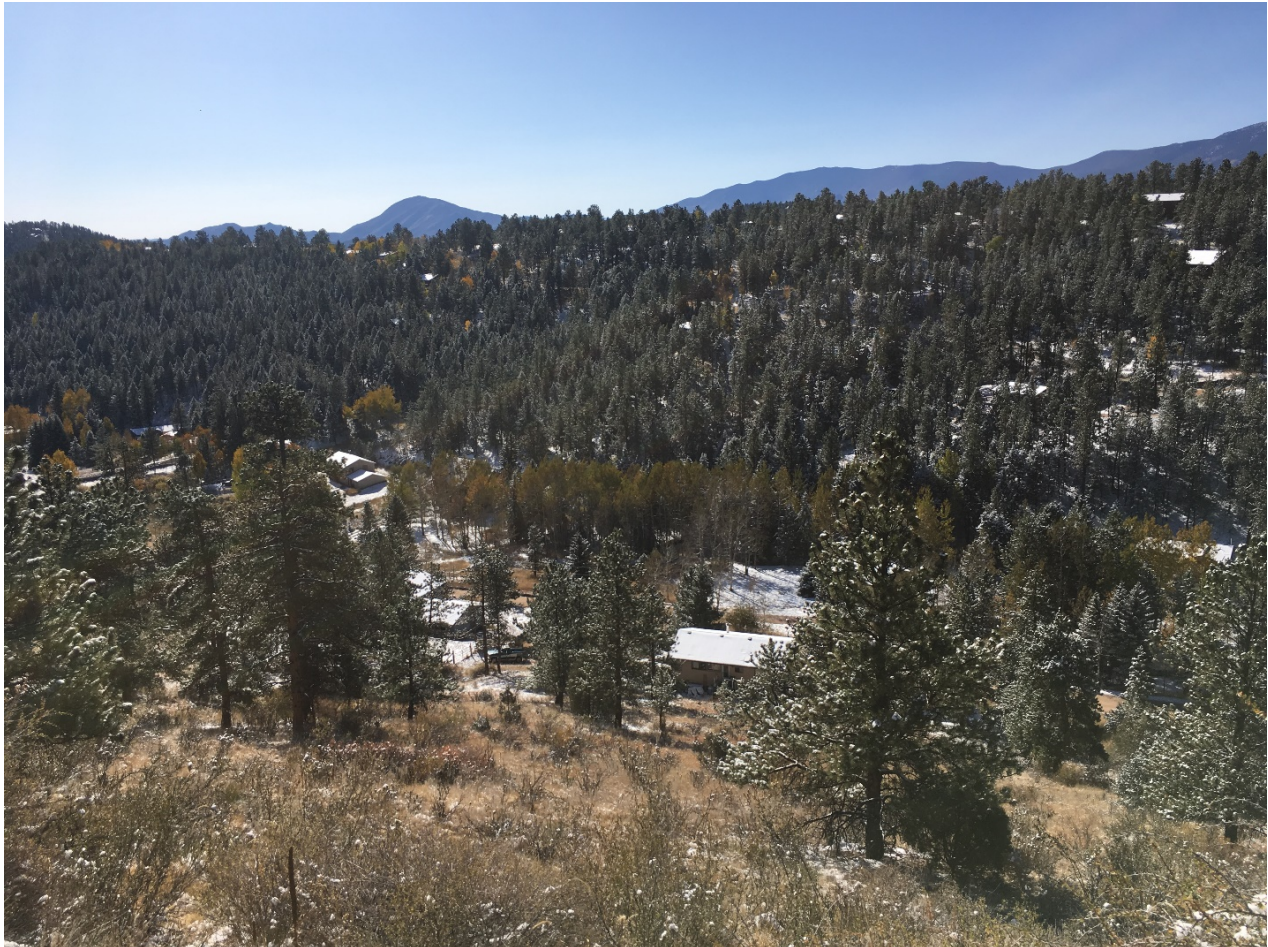
Roadways in Roland are wide and of decent quality making fire access a major positive, but steep turnarounds on North facing slopes could prevent engines larger than a type 6 from approaching homes. Ponderosa fuel is spaced too close together, particularly endangering homes placed mid-slope or on ridge tops. Defensible space needs some major effort in this neighborhood with more individual homes participating. With adjacent fuels in consideration, a wildfire would travel quickly in this area with plenty of heavy fuels. Housing materials should be improved with less wood use overall to reduce home loss severity. Many homes have wooden decks and wooden siding, with older-looking asphalt shingled roofs, making ember ignition a real possibility. Roland's Hazard Assessment value is 4 due to all of these factors.

Roland has an extreme number of structures exposed to short-range spotting and radiant heat, making structure loss inevitable without major defensible space and home hardening work.

Roland has a long evacuation time even on a good day with major congestion. Roadway thinning is essential if people, particularly living at the far southern end of Roland, need to evacuate safely. There is an alarming amount of Evacuation Pinch Points in Roland that need to be a number one priority for mitigation action, along with improvements to shelter-in-place locations. There are 439 structures in Roland, all exposed to long-range embers.

High Priority Implementation Project: Roadway thinning must occur as soon as possible from the entrance off US 285 on Roland Drive, down the valley through brookside and up the ridge following along through County Road 72. Along 72, the roadway treatment should account for slope and be designed in improve tactical options for defense of this community. Currently the fuel loading in Roland Gulch and the Deer Creek drainage to the West will create extreme fire behavior.

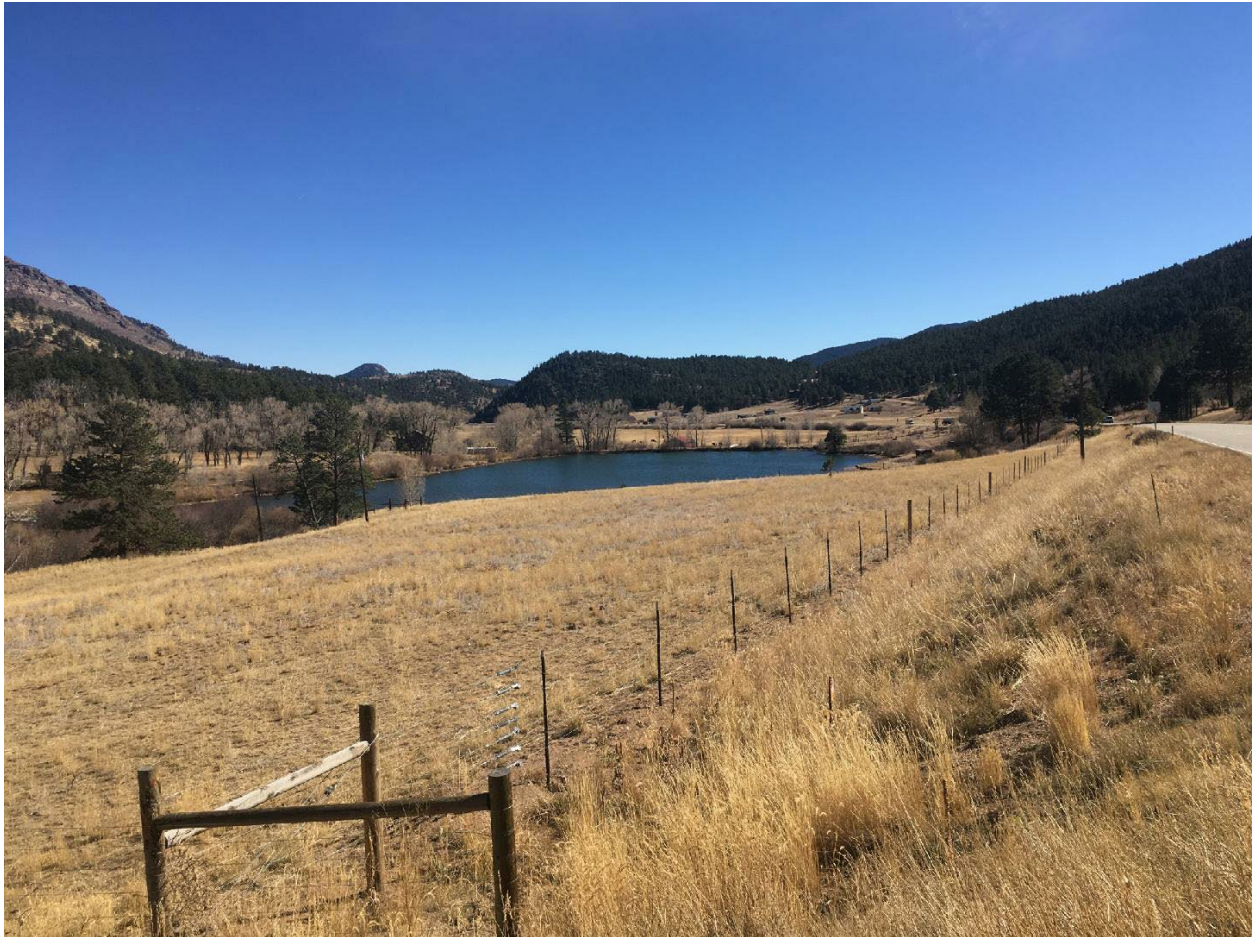
Shawnee's population is situated very close to 285 in flat terrain. Ponderosa Pines here are well spaced and homes are defensible. On the north side of 285 is a large ranch that would be a good shelter in place location. The schools located in this area are nearby and adjacent to the same shelter in place location that should be a clear place for survival during a wildfire. Care should be taken to harden historical structures that have flammable building materials. With very small defensible space changes like gravel beds surrounding the home would dramatically improve structure survival. The Hazard Assessment value for this neighborhood is 1 as most homes here are in good condition.

There are 139 structures in Shawnee. Shelter-In-Place for Shawnee is very abundant, and few structures are at risk of radiant heat or short-range embers. Roadway survivability under 90th percentile fire weather is a concern in populated areas of Shawnee, but flat terrain will make

mitigation projects successful. Due to the grass fuel type, rates of spread will be high in this neighborhood. This should be considered if residents are directed to shelter-in-place in this area.

High Priority Implementation Project: Thinning treatments along roadways with higher population in Shawnee should be thinned to a minimum 300-foot distance. This will facilitate any egress that does not go as planned. Many residents of Platte Canyon may end up in this area during an evacuation, so having adequately mitigated roadways will facilitate any evacuation scenarios that arise.

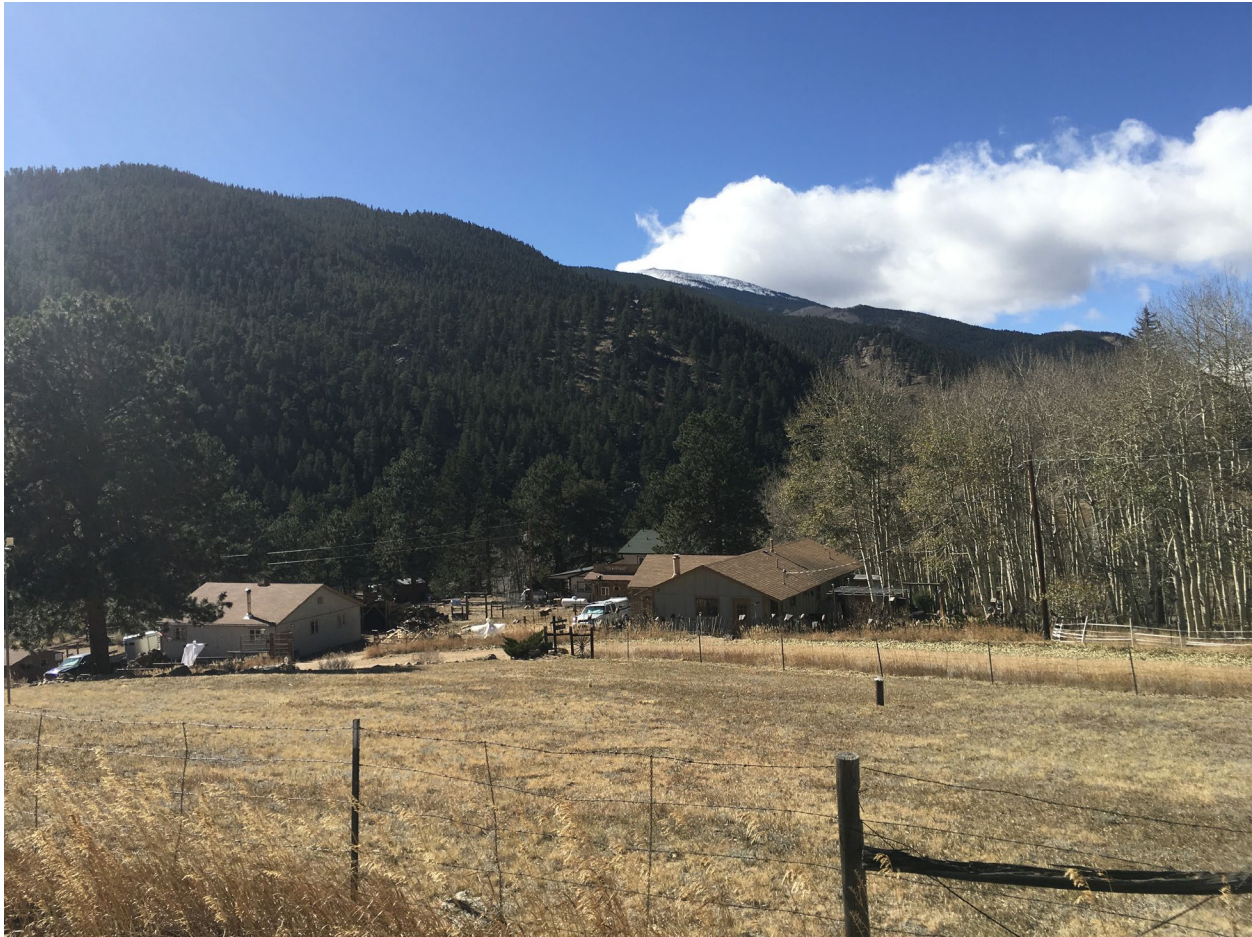
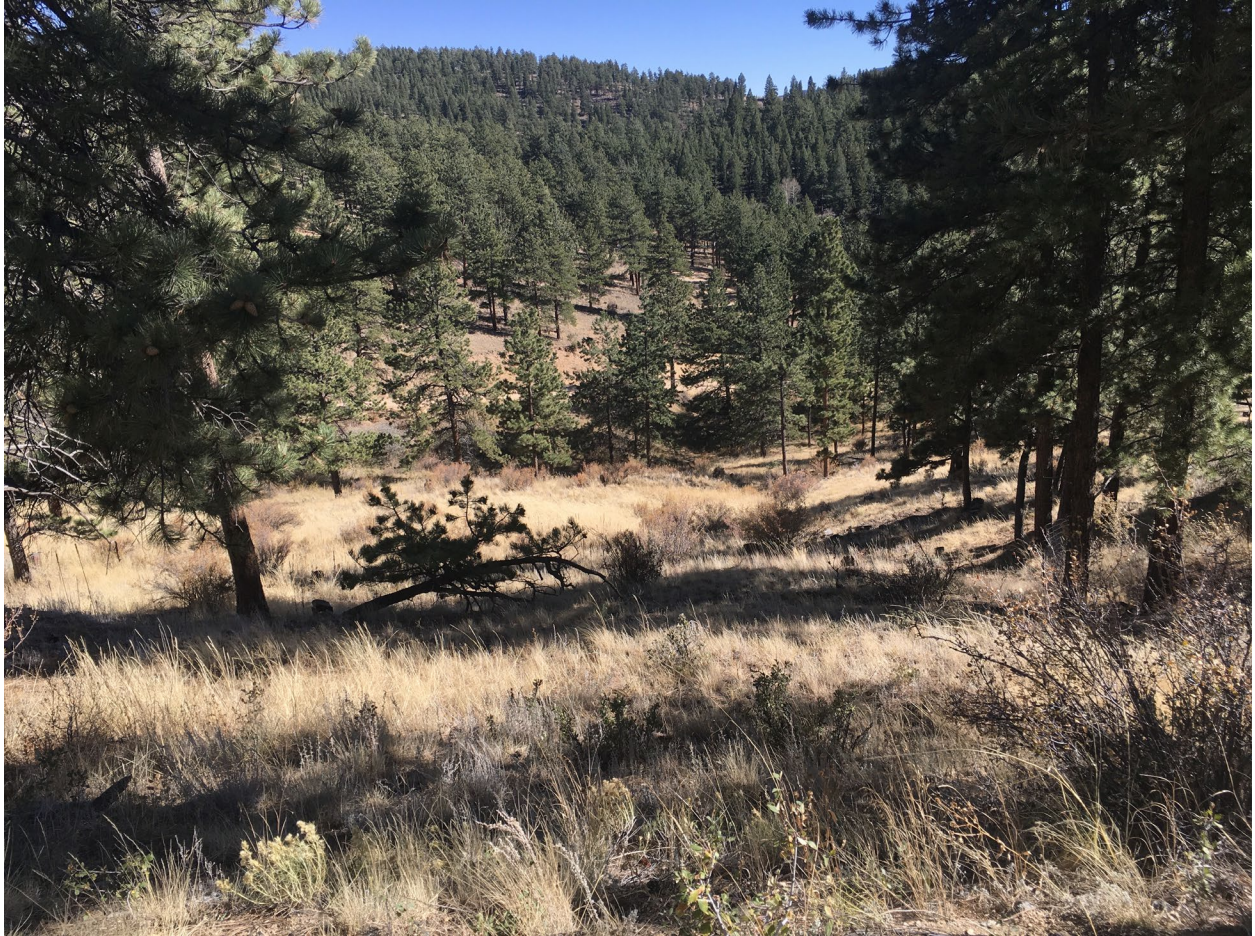
Belford and Singleton Estates

Homes close to 285 in these neighborhoods are located in relatively flat terrain with open ponderosa forest structure. Following narrow gravel roads north in the upper Singleton Estates, steeper topography assigns more risk to those homes. In this upper portion, steep topography will make mitigation work much more important for home survival. Defensible space is pretty good throughout the neighborhood. Certain areas have mitigated Ponderosa density and canopy height but could do a very minimal thinning to dramatically improve safety. Unmarked weight restrictions on each bridge could prevent rapid fire response and should be remedied. Overall, the Hazard Assessment value for this neighborhood is 2, but homes in steeper terrain are at higher risk than that.

Shelter-in-place could occur in some of the meadows close to US 285, but work is needed to make them accessible. Portions of most roadways have non-survivable sections, but no major points of egress are entirely vegetated. Homes along Cline Drive E are at greatest risk from radiant heat and short-range embers and should be a focusing on Home Ignition Zone improvements. There are 105 structures mapped in this neighborhood.

High Priority Implementation Project: A neighborhood-wide thinning project to have 15-foot canopy spacing would dramatically change the risk to life safety and home ignitability. This project should start in the major drainages. Much of the neighborhood already has good tree spacing, so to improve the areas that don't have those forest conditions would be little work for high impact.

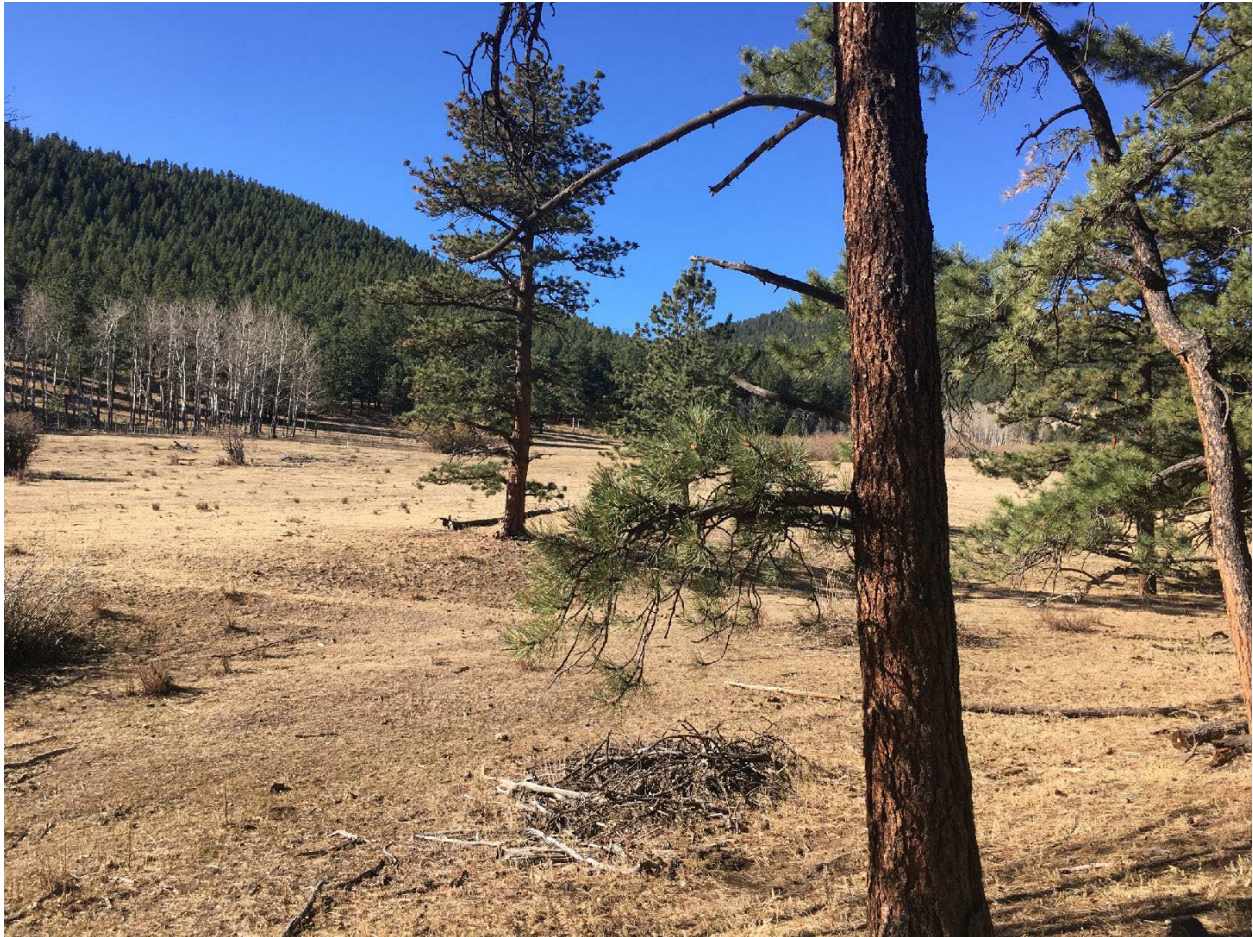
Tomahawk GS Ranch

This ranch is in good shape with recent mitigation efforts. Some structures on the western side of the camp are in denser fuels and could be safer with some modification to forest structure. This area is mostly populated in the summer and does have apparent fuels treatment ongoing. Shelter-in-place options can be continuously improved, but overall this ranch is in good condition. Older structures are present, but as these are not primary residences, it would be up to the camp if they were worth hardening. This area has a Hazard Assessment value of 2.

Evacuation of this camp is in pretty good shape. There is a worst-case-scenario place to shelter and County Road 43 is nearby. In the event campers and staff are unable to evacuate this neighborhood, roadways that are not survivable under 90th percentile fire weather should be mitigated. There are 21 mapped structures at this camp.

High Priority Implementation Project: Roadway thinning treatments should be added on all the roads they are currently not present on. Thinning distance should be a minimum of 300-feet wide and follow Appendix 7 for other treatment parameters.

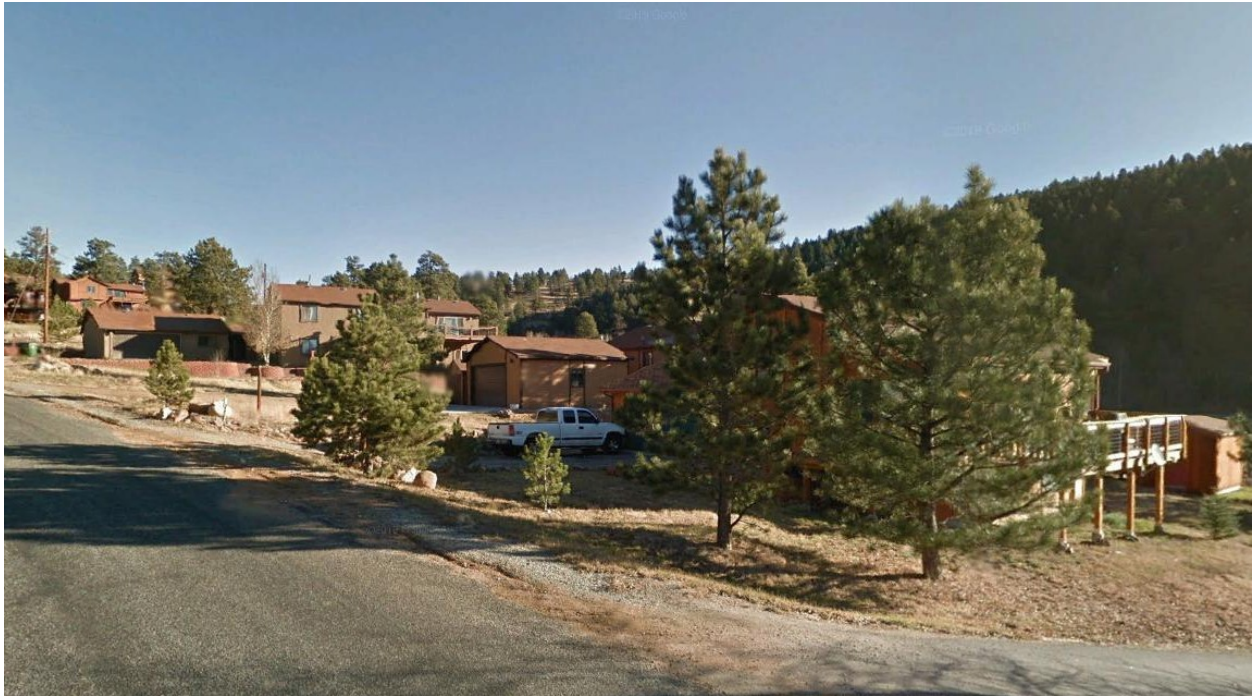
Will-O-Wisp sits along 285 with only one major evacuation route. Most homes sit in a slight valley with light fuel loading. A major concern is the density of homes – with ember cast, house to house ignitions could be a very likely. Home hardening is not apparent with many homes having wooden decks and siding or aging asphalt roofs. Fuel load gets heavier in the south part of the neighborhood as lot size increases. These homes should focus on defensible space, as no work is apparent. Young ponderosa and willow in the valley are particularly concerning fuels. The Southern portion of the neighborhood gives this a Hazard Assessment value of 3.

Shelter-in-Place for this neighborhood is not ideal, but there is a location along US 285 that could work depending on congestion. Will-O-Wisp shows evacuation congestion in areas of low roadway survivability. Slope will dictate wide roadway fuels mitigation treatments. Homes in this neighborhood are surrounded by high fuel load and will experience strong ember wash. There are 122 mapped structures here.

High Priority Implementation Project: Roadway thinning projects of 300-feet minimum width along Wisp Creek Drive will impact all residents of this neighborhood. This road has Evacuation Pinch Points that will threaten life safety in an emergency scenario. Increasing canopy spacing and maintaining this treatment along the road is the most important short and long-term project.

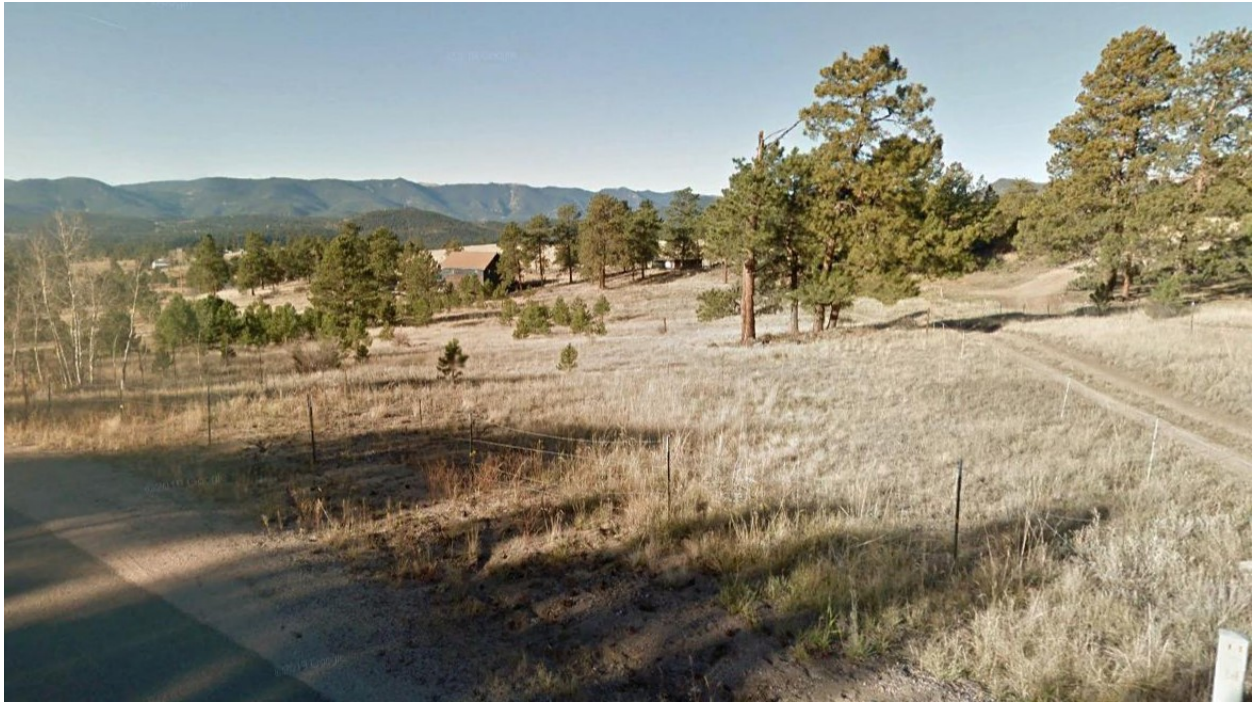
Wondcrest sits off of 285 with a single exit location onto 285. This neighborhood sits in a relatively flat upland area, with low fuel density. Most homes have good defensible space around them with newer construction materials and larger lot sizes. Livestock could be the main evacuation concern, but roadways are in good shape and wide enough for simultaneous ingress and egress. The only roadway that is concerning is along Wondcrest Park Road between Park Avenue and Silver Springs Road with denser vegetation along the roadway. The Hazard Assessment value for this neighborhood is 1.

Residents could Shelter-in-place in a worst-case-scenario in the Southern end of the neighborhood, avoiding the edge where fire behavior will be more intense coming out of Roland Gulch. Home Hardening will be important to support the Defensible Space present in this neighborhood. Fuels downslope in Roland are high and embers will affect structures, even if they are long-range embers. There are 82 structures in Wondcrest.

High Priority Implementation Project: Roadway thinning treatments along Wondcrest Park Road would be a great project to solidify the defensibility of this neighborhood. With the flat terrain here, 300-feet of thinning treatment would be plenty to improve egress.

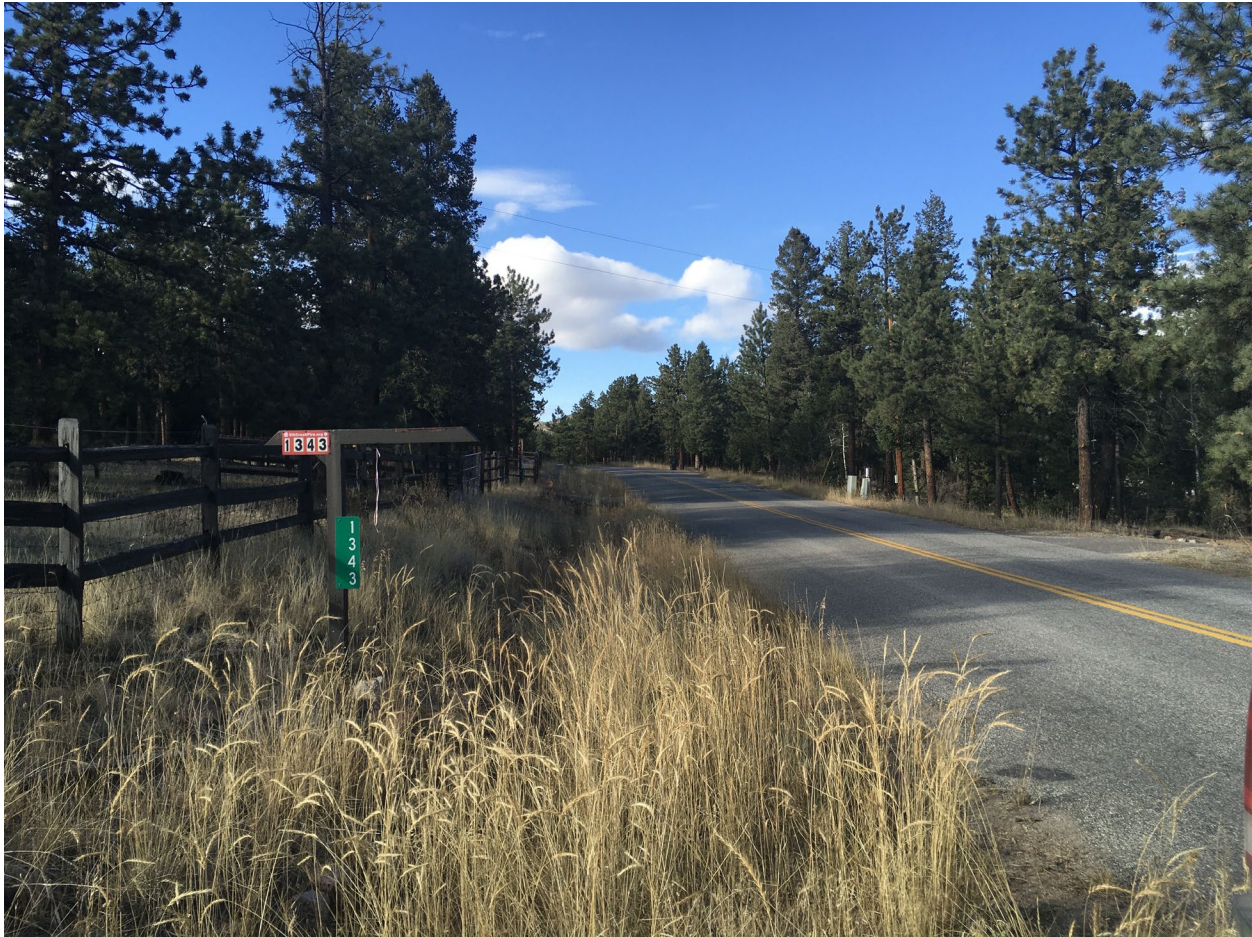
Woodside 1

Home Defensible Space needs major improvement in this neighborhood. Dense ponderosa towers over homes with no space to defend a structure from a flame front. Some choices on flammable construction materials and woodpiles close to homes should be remedied in conjunction with fuels treatments in all neighborhoods. Major roads are in good condition, but roadside treatments would assist in roadway survivability during a flame front. Flat terrain benefits these residents and will make mitigation work extremely successful when executed. Shelter-in-place in nearby meadows is a major positive that residents will benefit from in a worst-case scenario.

This neighborhood has 328 structures. Embers and radiant heat risk are high in this neighborhood, but most risk could reasonably be mitigated by defensible space work. The main concern for this neighborhood is egress along Mt. Evans Boulevard. Much of that

High Priority Implementation Project: Fuel loading is spotty, but intense in places of this neighborhood. Roadway thinning projects should be first priority here and would help improve overall fuel loading. First area of concern should be Mt. Evans Boulevard to mitigate the Evacuation Pinch Points. Mostly flat terrain will allow a 300-foot treatment to be sufficient, but care must be taken to complete wider treatments in areas of steeper slope.

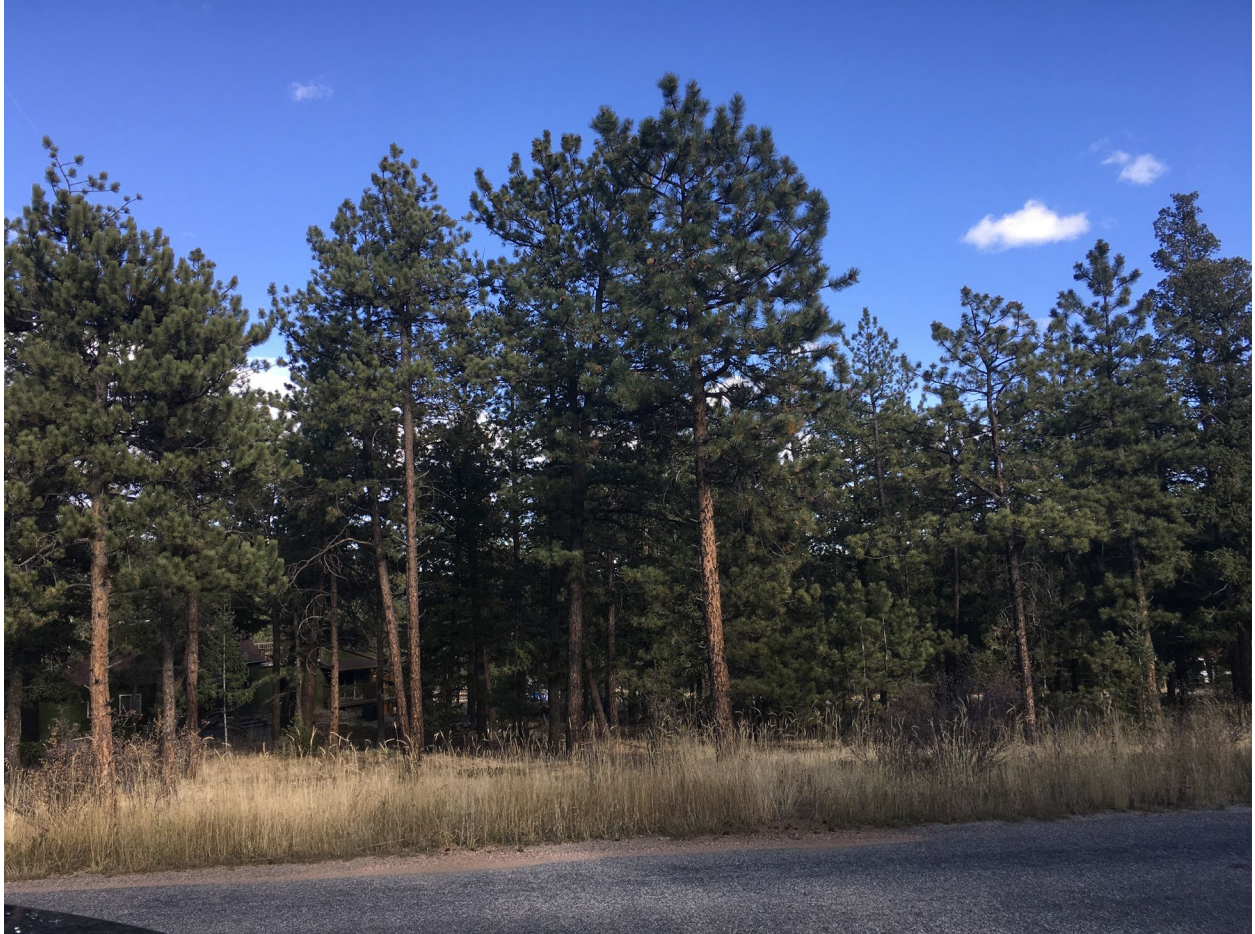
Woodside 2 sits closest to 285 along the Mt. Evans corridor, but has major housing construction issues. Some Home Ignition Zone work has been completed, but linked defensible space needs to be prioritized. Dog hair ponderosa is prevalent which may suggest that fuels treatment maintenance is not occurring. Lots of wood fences, decks and natural ladder fuels could create intense fire behavior and rates of spread. This neighborhood has a Hazard Assessment value of 3 that would quickly lessen with additional Home Ignition Zone improvement.

Though close to 285, evacuation remains a concern for this neighborhood as major congestion is shown in this area. Thinning treatments on roadsides will benefit all other residents travelling through for egress, as well as help residents that live in this neighborhood greatly. Some of the Home Ignition Zone work is reflected in the lack of structures exposed to radiant heat. Long-

range spotting is still a major consideration, so home hardening can be a high priority for each resident, as well as maintaining the fuels treatments present. There are 115 structures mapped in this neighborhood.

High Priority Implementation Project: Roadway thinning projects should be first priority here and would help improve overall egress during a wildfire. First area of concern should be Mt. Evans Boulevard to mitigate the Evacuation Pinch Points. Mostly flat terrain will allow a 300-foot treatment to be sufficient, but care must be taken to complete wider treatments in areas of steeper slope.
