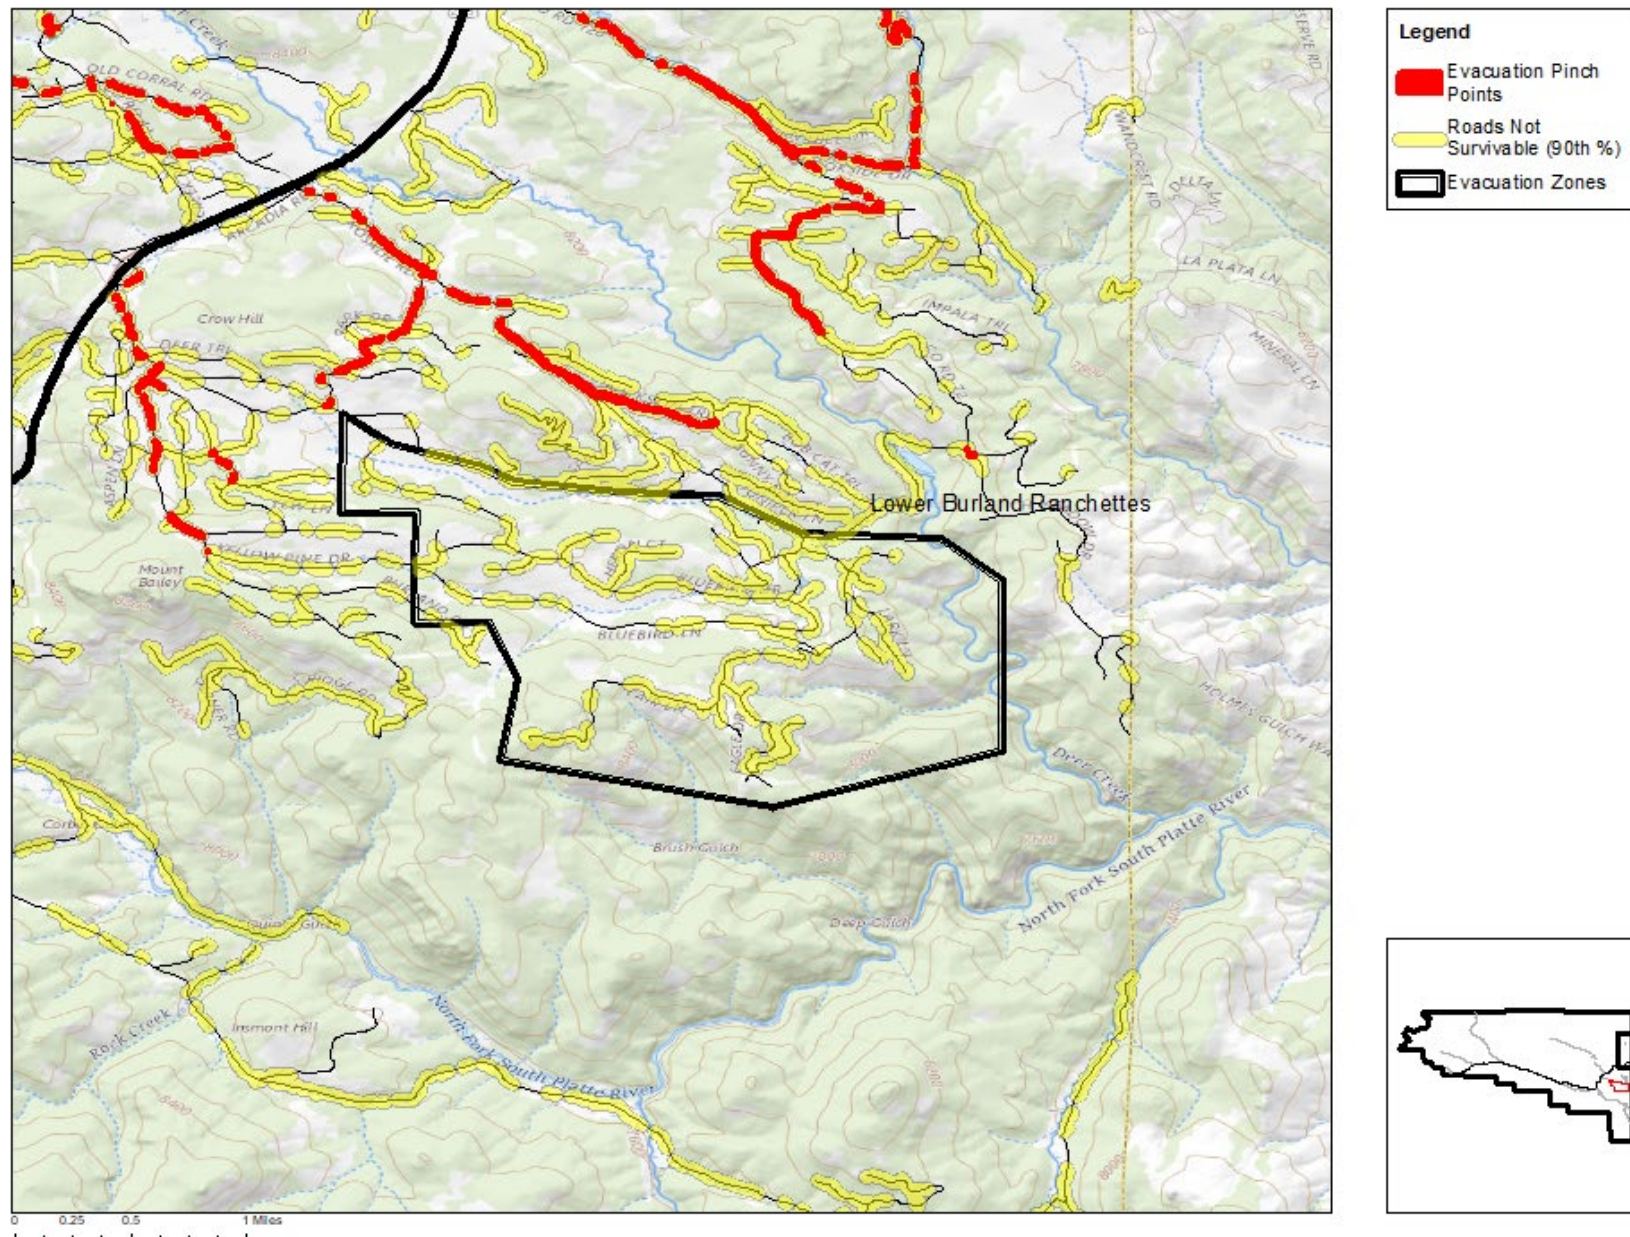
## Evacuation Zone: Lower Burland Ranchettes - Rating: High

This community is just south of Burland, below County Road 72, with much steeper slopes and older housing stock. The only short, evacuation route out is through Rosalie Road with good road quality. Very few homes have obvious defensible space work and could improve visibility of addresses and street signs. Roofs appear in newer condition, but wooden fences, decks, and siding are apparent. Terrain is a major factor in this neighborhood and will make fire behavior and suppression quite difficult. Housing materials and distance to US 285 make this neighborhood's Hazard Assessment value a 4.

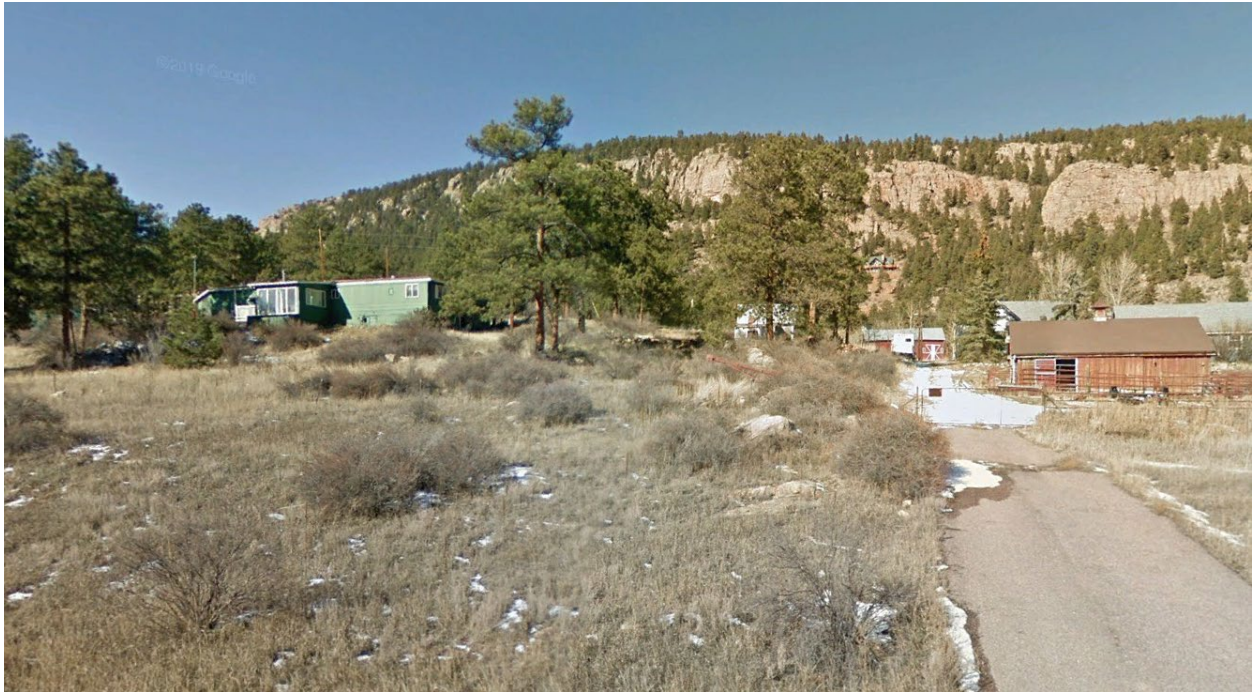
McKinley sits along 285 near the entrance to Platte Canyon Fire Protection District. Vegetation is less dense and with a little bit of thinning to create more space between trees, this community is sitting in a great place. Housing stock is from around 1970s and has decent conditions Class A roofs with some wooden outbuildings, fencing, and decks on or near homes. Egress in this community is great with multiple exit points. The Hazard Assessment value for this neighborhood is 1 as most homes here are in good condition.

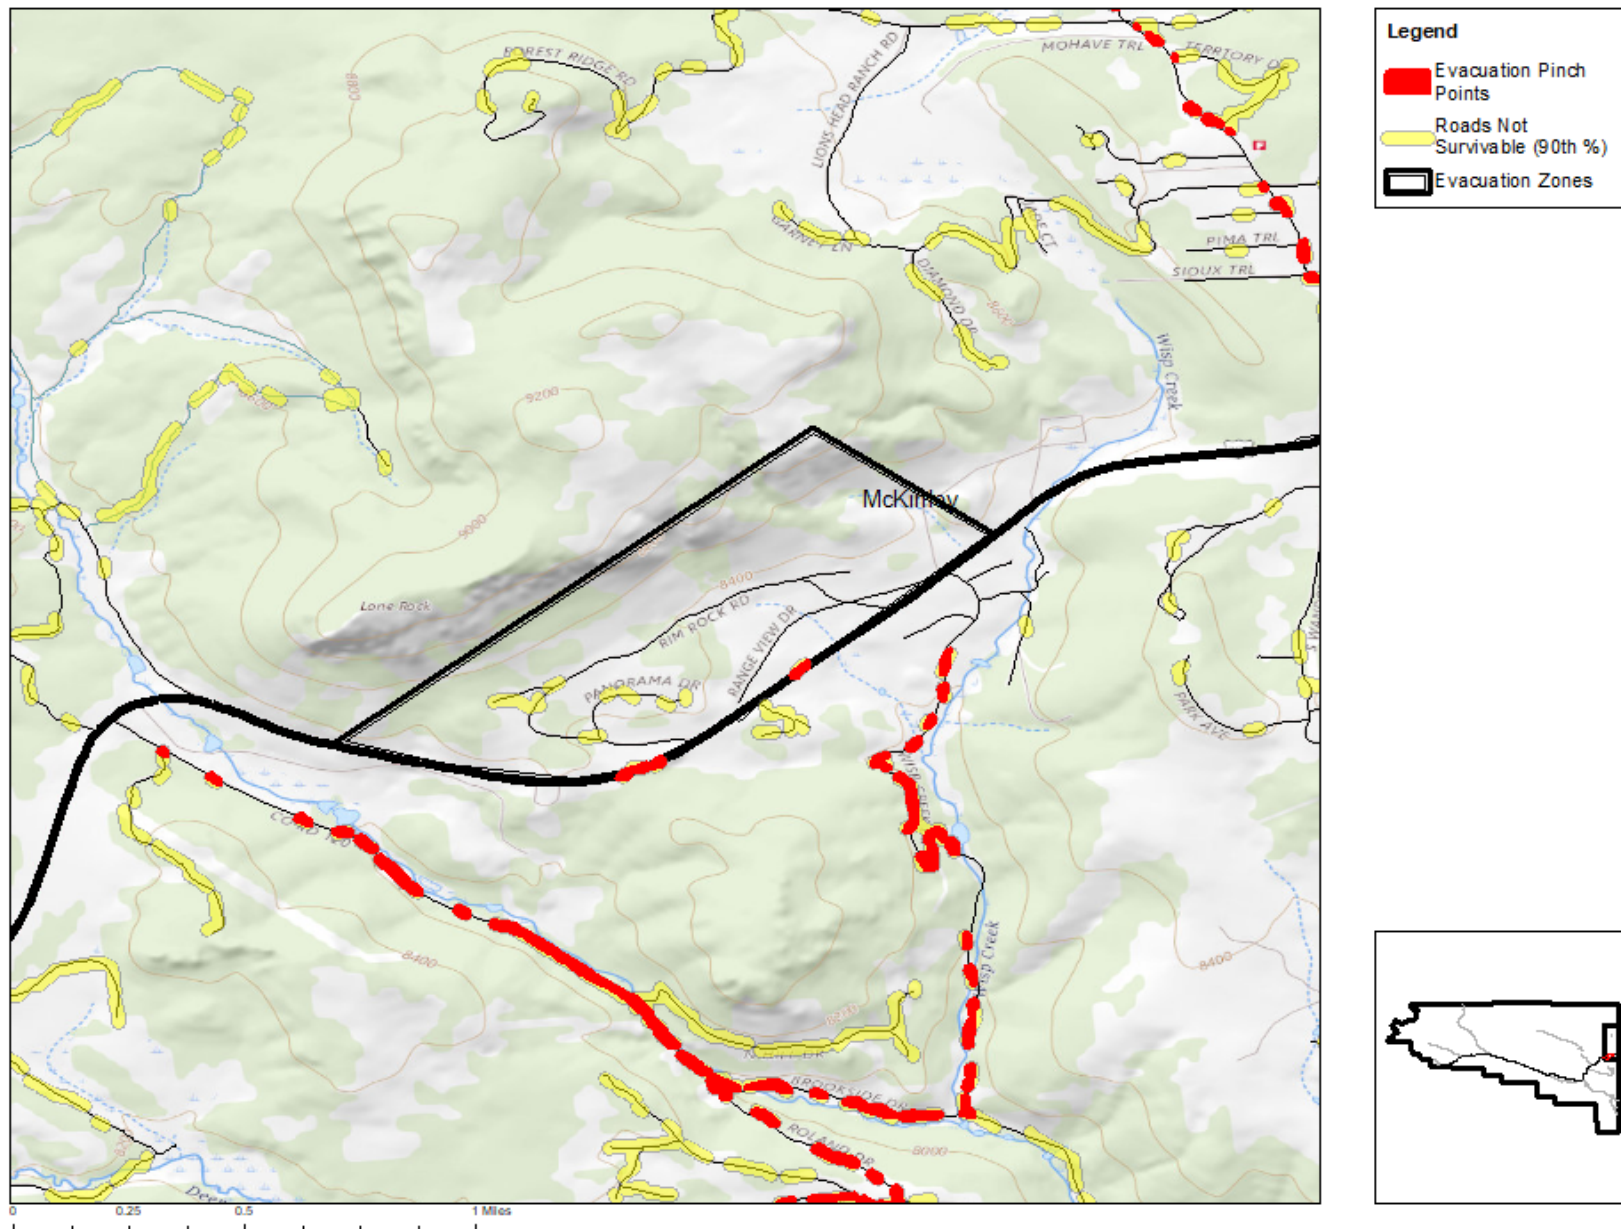
## Evacuation Zone: McKinley - Rating: Moderate

There are 77 structures in McKinley. So few structures and roadways are at risk of intense fire behavior in this neighborhood, the main evacuation concern would be related to any traffic backup on US 285. Rates of spread in this grass dominated fuel type would be the main fire behavior factor to be aware of. Home Hardening practices will be very successful in this neighborhood, as Defensible Space is already present.
